# *Danielskuil*

PHASE 1 HERITAGE INVENTORY AND ASSESSMENT  
OF THE TOWN DANIELSKUIL,  
KGATELOPELE LOCAL MUNICIPALITY,  
ZF MGCAWU DISTRICT MUNICIPALITY,  
NORTHERN CAPE.

SEPTEMBER 2021

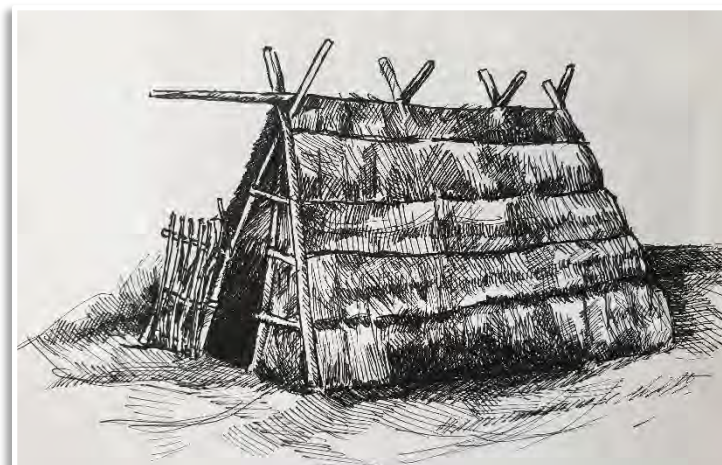
These A-framed houses had a paired couple frame which was thatched with reeds and thatching grass. Low sidewalls supported the couples' feet to prevent them from decaying if embedded in the ground. The entrance was situated on one end, and two small windows illuminated it. The roof was characterised by a thick piece of wood along the length of the roof. The wood was tied to the crotch and formed a ridge.<sup>40</sup>

Early Kapstijl house made of thatch, reeds and wooden A-frame. Image: H. Fivaz

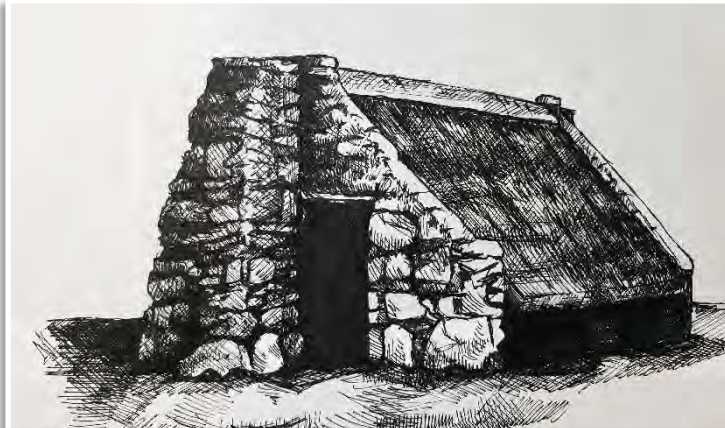
Later Kapstijl house with A-framed stone wall and thatch roof. Image: H. Fivaz

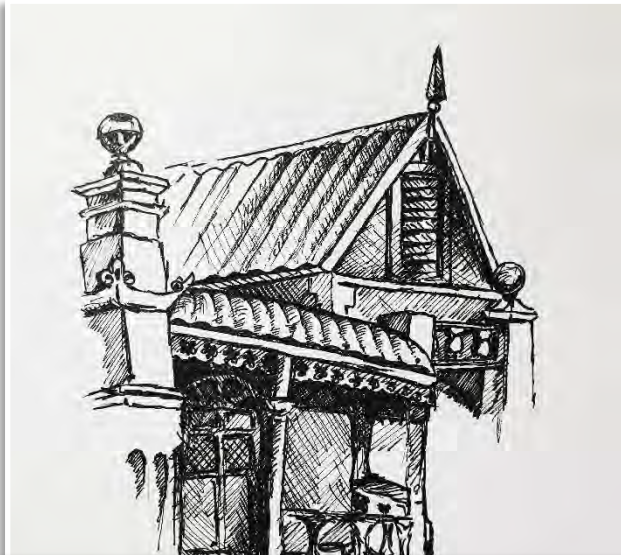
Victorian and Edwardian features. Image: H. Fivaz

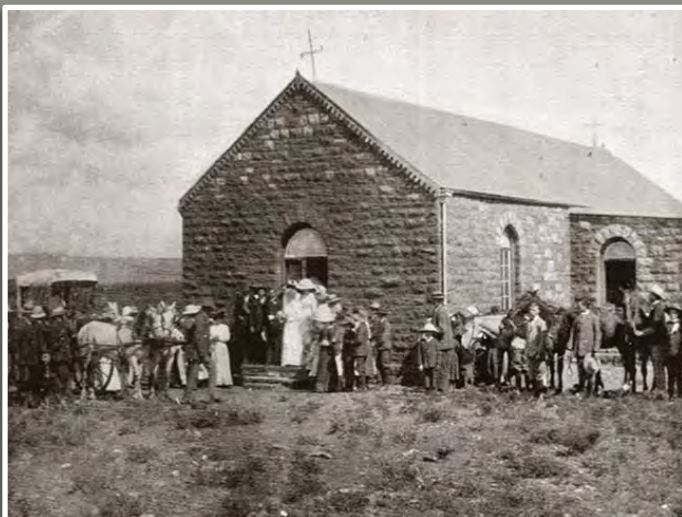
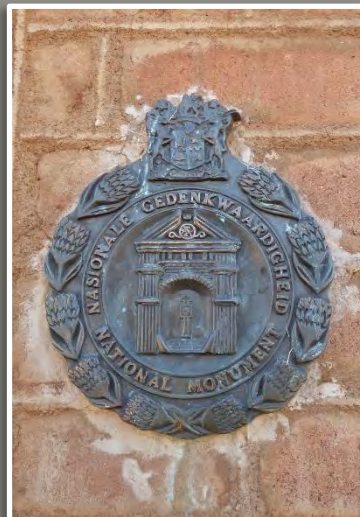
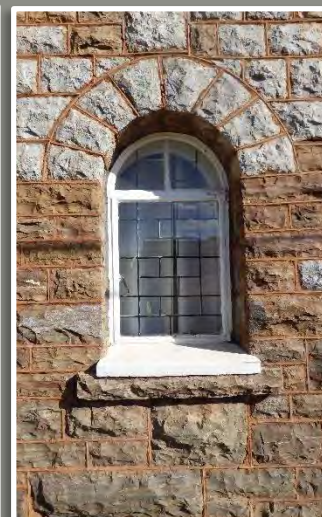
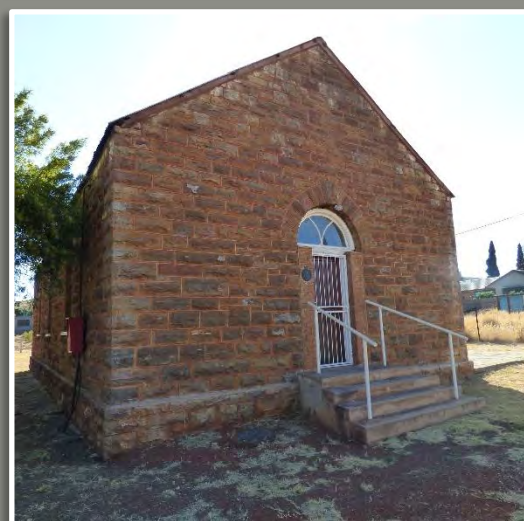
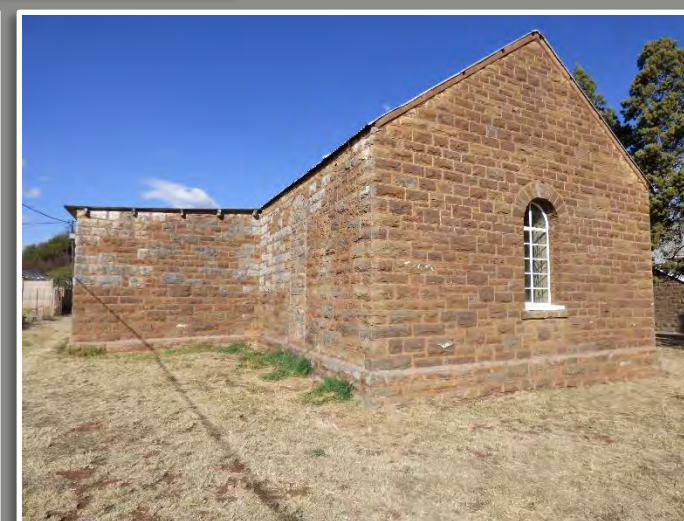
## 1. CHURCHES: *The First Dutch Reformed Church*

| SITE DESCRIPTION | | | | | | |
|---|---|---|---|---|---|---|
| Condition | Good condition.<br>National monument plaque next to the front door. | | | | | |
| Past Renovations, Alterations, Restorations | New corrugated roof. A non-modern looking window was built into the NW wall. Cement steps, new bricks, and a handrail have been added to the eastern entrance. Burglar bars have been added to the inside and outside of windows and new doors installed. Electricity added. | | Identified Threats | | None. | |

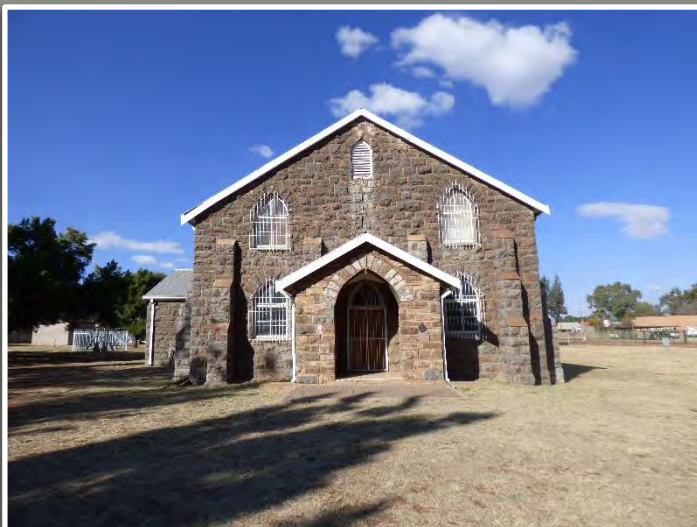
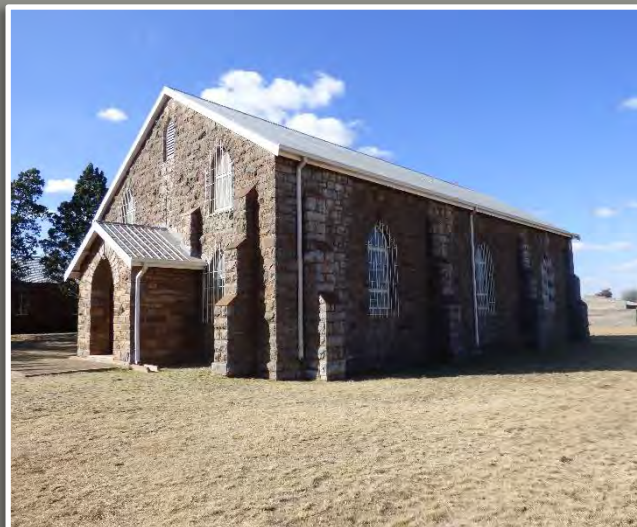
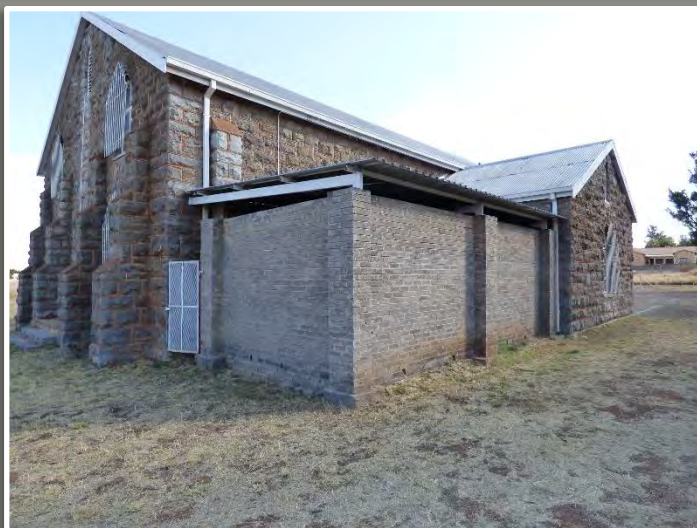
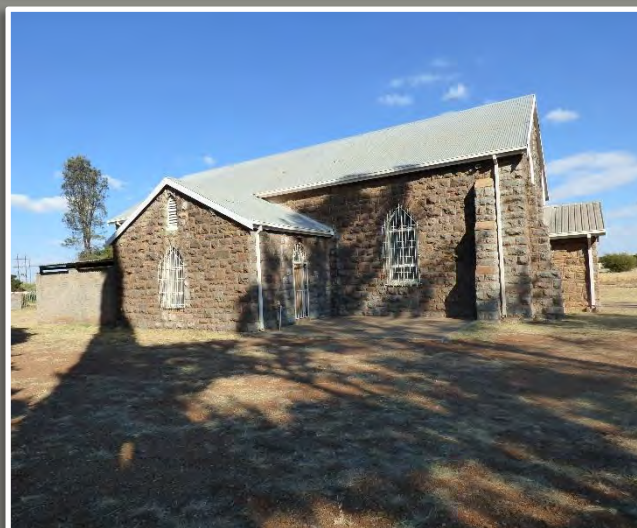
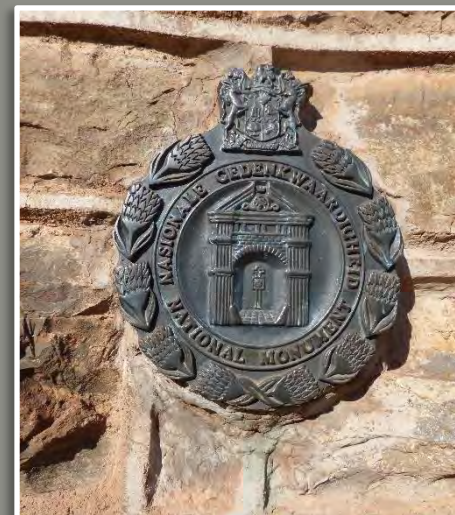
## 2. CHURCHES: *The Second Dutch Reformed Church*

| SITE DESCRIPTION | | | | | | |
|---|---|---|---|---|---|---|
| Condition | Good condition.<br>National monument plaque next to the front door. | | | | | |
| Past Renovations, Alterations, Restorations | New corrugated iron roof. Recent ash brick utility extension on the northeastern corner of the church, paving and tiles at the western entrance, white burglar bars in front of windows, and new light fixtures. | | Identified Threats | None. | | |

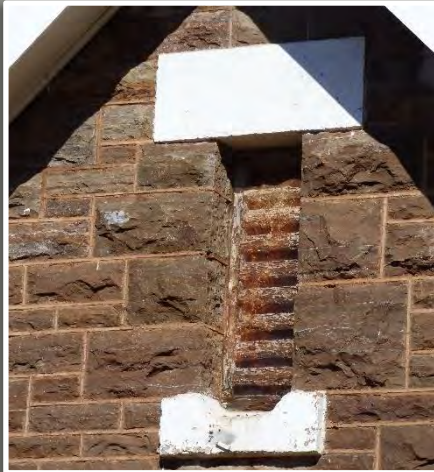
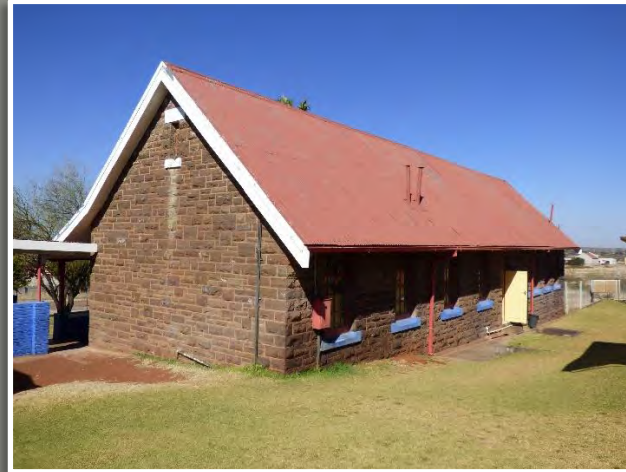
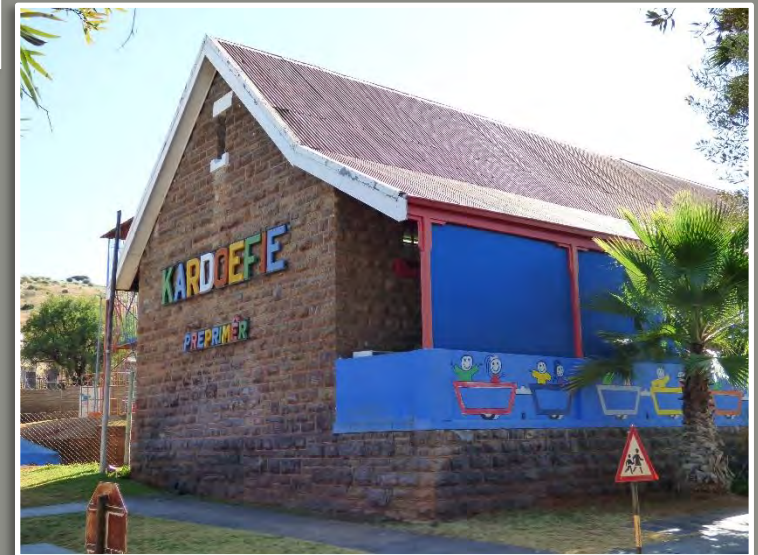
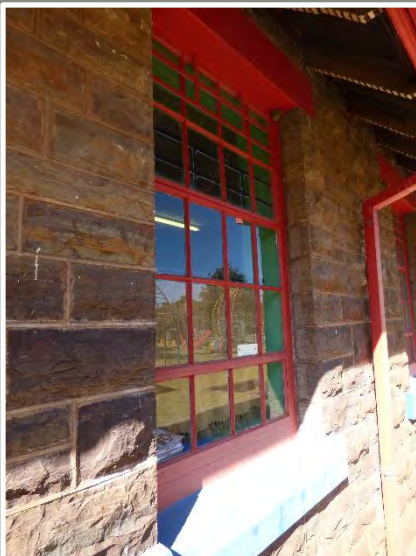
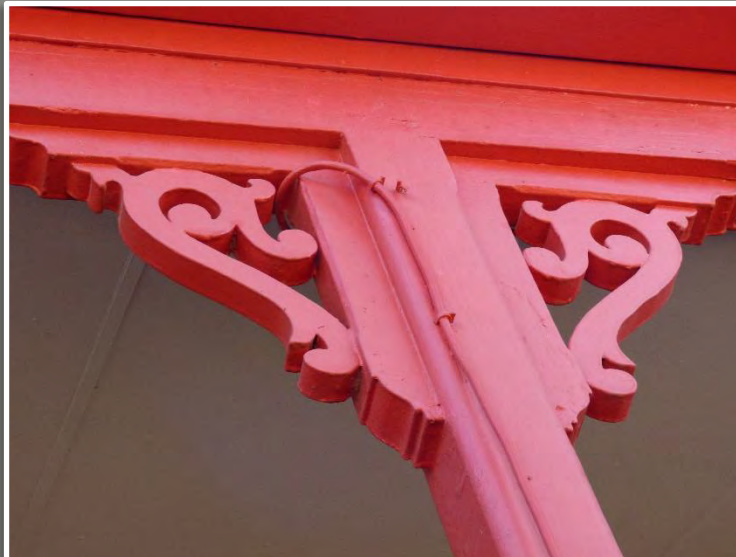
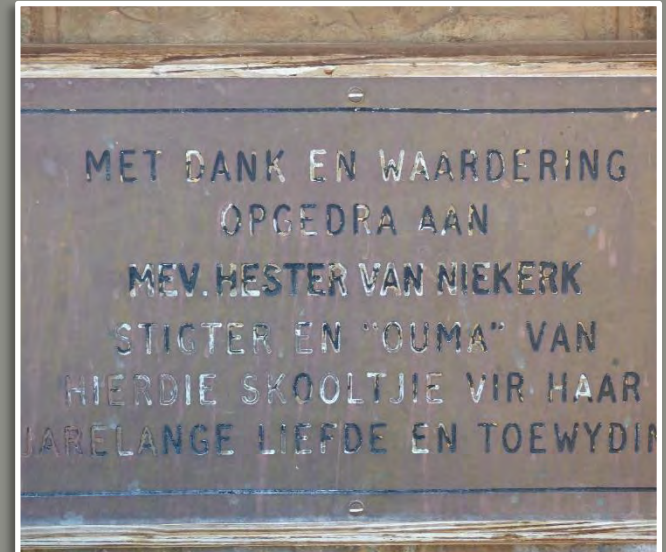
### 3. SCHOOL: Kardoefie Pre-primary

| SITE DESCRIPTION | | | | | | |
|---|---|---|---|---|---|---|
| Condition | Good | | | | | |
| Past Renovations, Alterations, Restorations | Facia boards and ceiling added later—modern walls on the north and south end of the veranda. Outer buildings were added later in the 1980s. Interior altered, painted and electricity. | | Identified Threats | Wall cracks and mortar are absent in certain places in the walls. | | |

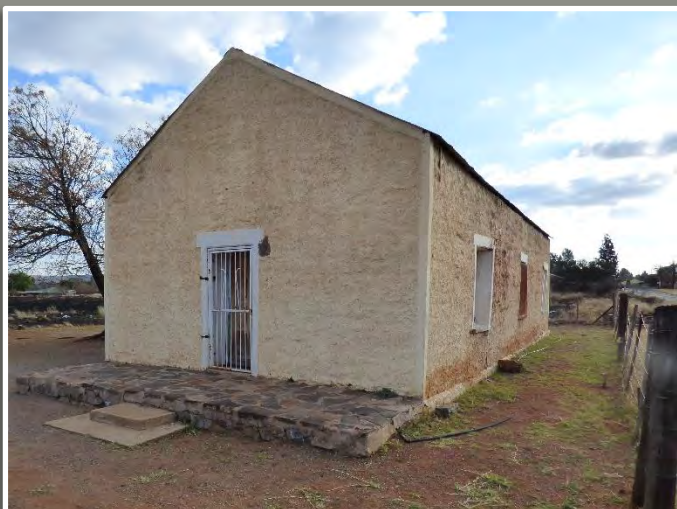
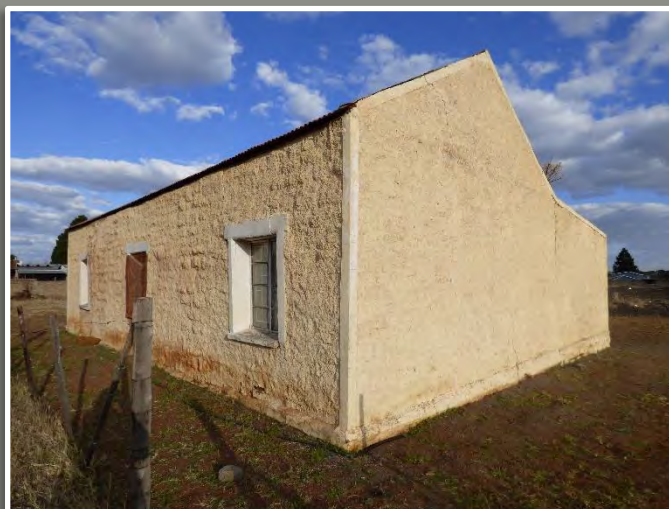
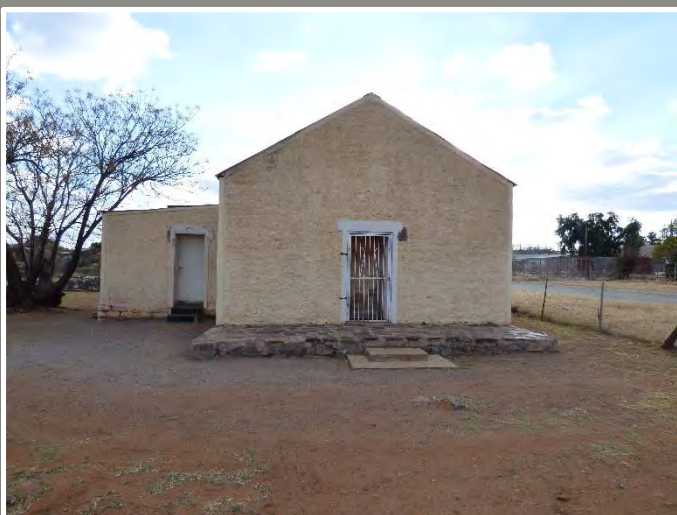
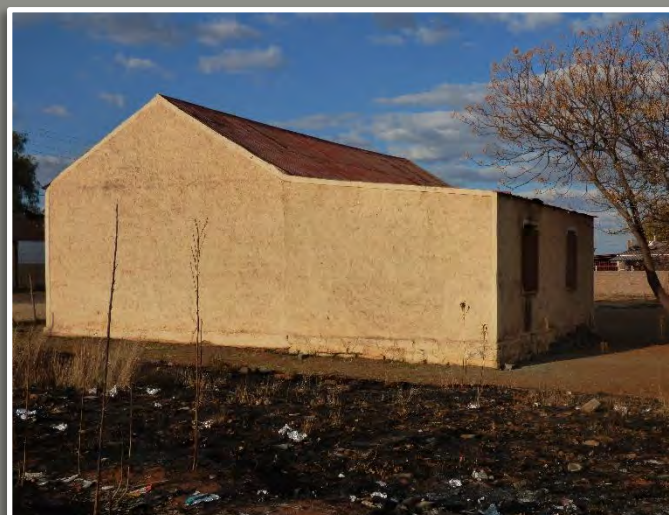
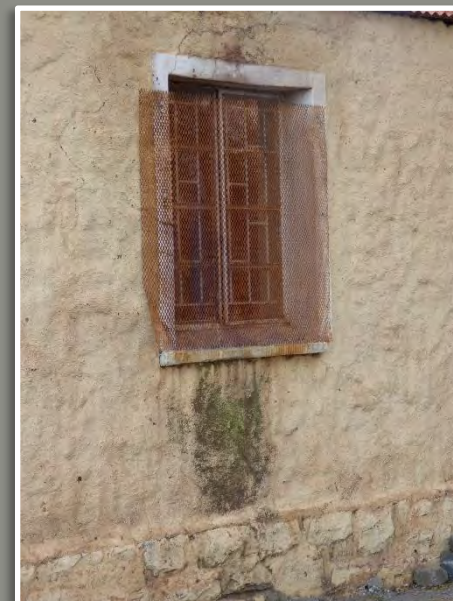
#### 4. CHURCHES: *The Old Congregational Church*

| SITE DESCRIPTION | | | | | | |
|---|---|---|---|---|---|---|
| Description of Architectural Features | The building is L-shaped with an added wing on the south. The structure has a stone foundation with clay bricks plastered with lime. The original wooden roof frame is still in place, with a corrugated-iron roof. The deep-set windows and doors are in their original positions. The main entrance is situated on the East with a shale stoep. Entrance facing east. Stone-built foundations of demolished buildings surround the churchyard. | | | | | |
| Condition | Poor. There are cracks in the walls, and the roof is lifting up from the base walls. Damp patches are visible on some regions of the walls. | | | | | |

| SITE DESCRIPTION | | | | | | |
|---|---|---|---|---|---|---|
| Past Renovations, Alterations, Restorations | Repainting and window-pane alterations or replacements have been done. Modernised steps have been added to the entrance of the southern building. Three windows are covered with expanded metal, and the front door is fitted with burglar bars. | Identified Threats | Neglect. Poor maintenance and degradation. Open field to the west and south with refuse dump that gets burnt regularly. | | | |

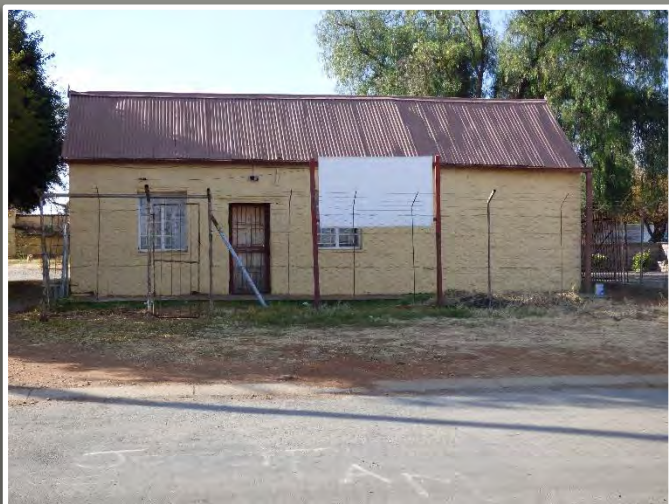
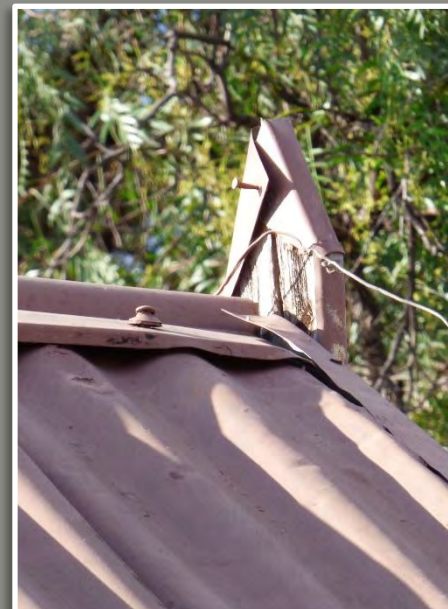
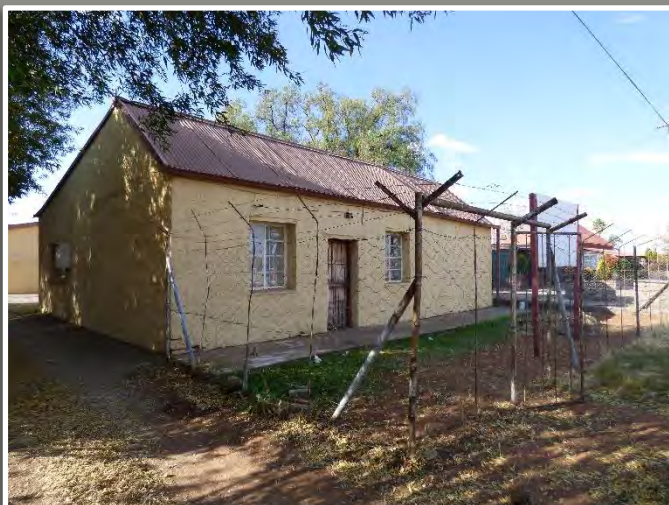
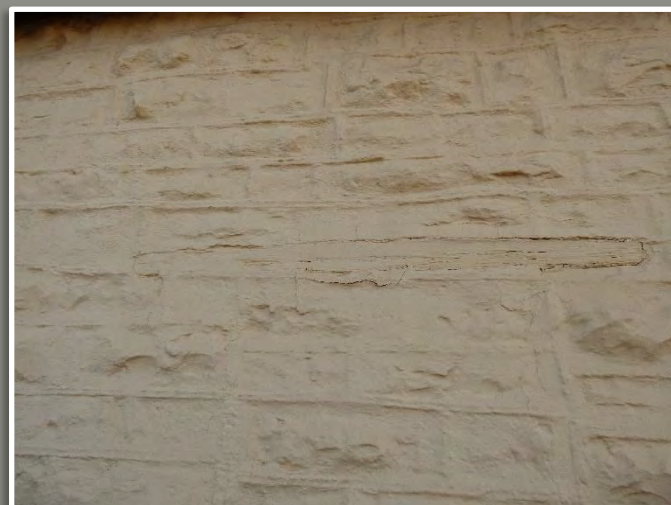
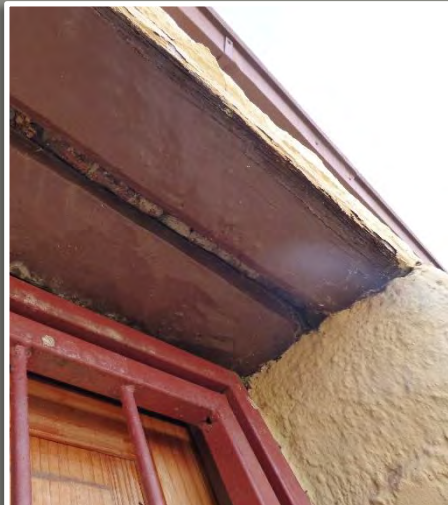
## 5. RESIDENTIAL: *Congregational Church Cottage*

| SITE DESCRIPTION | | | | | | |
|---|---|---|---|---|---|---|
| Condition | Fair, but maintenance is required | | | | | |

| SITE DESCRIPTION | | | | | | |
|---|---|---|---|---|---|---|
| Past Renovations, Alterations, Restorations | Northern side plastered, doors possibly replaced, painted and partially renovated. | | Identified Threats | Empty, lack of maintenance, unsecured | | |

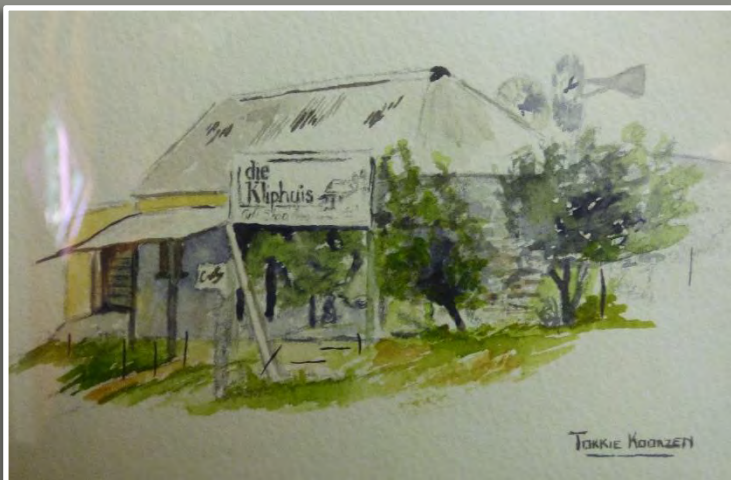
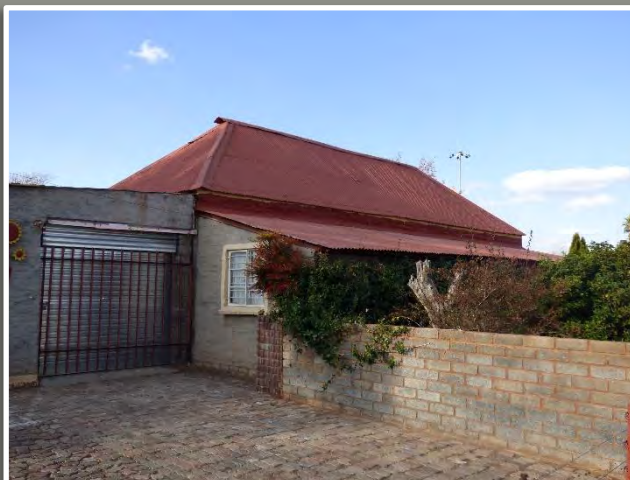
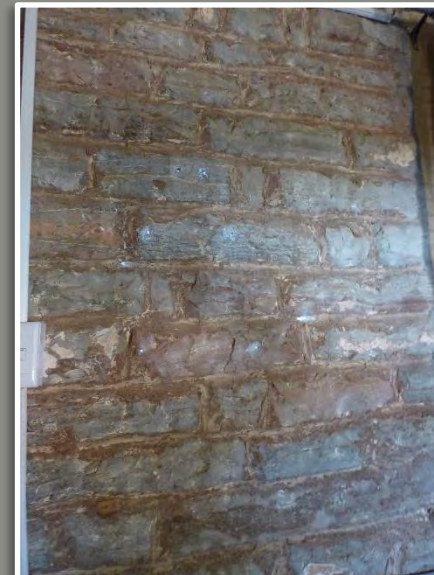
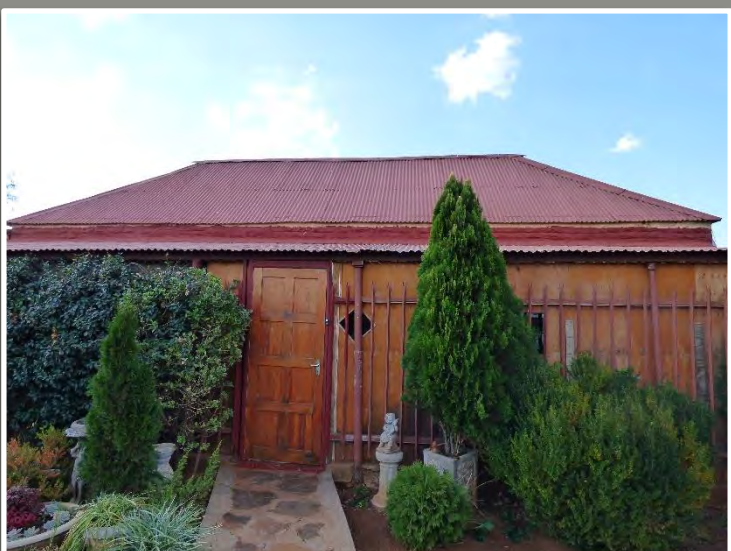
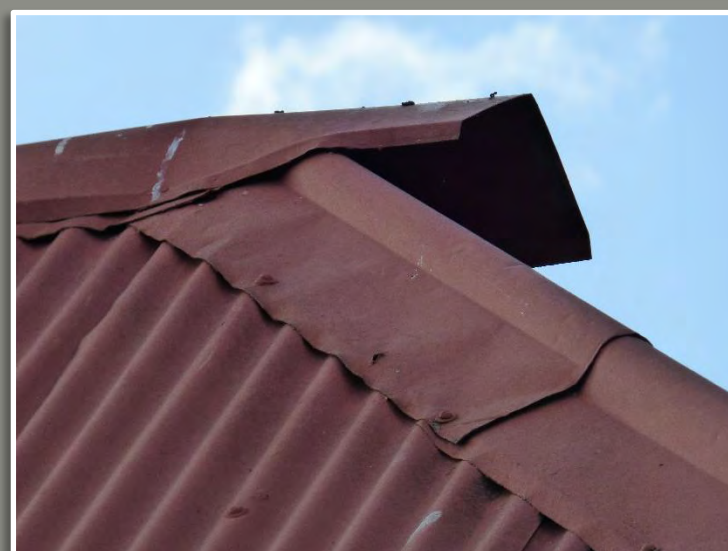
## 6. RESIDENTIAL: The “Kliphuis”

| SITE DESCRIPTION | | | | | | |
|---|---|---|---|---|---|---|
| Condition | Fair to good. Unfortunately, all the alterations and additions changed the significance level that can be attributed to the building. | | | | | |

| SITE DESCRIPTION | | | | | | |
|---|---|---|---|---|---|---|
| Past Renovations, Alterations, Restorations | Alterations were made to the interior and exterior. The veranda was closed up to add extra rooms. Additional walls, a garage and paving were added outside. The original windmill and reservoir present on the erven were removed—removal of windmill and reservoir initially present on erven. | | Identified Threats | None | | |

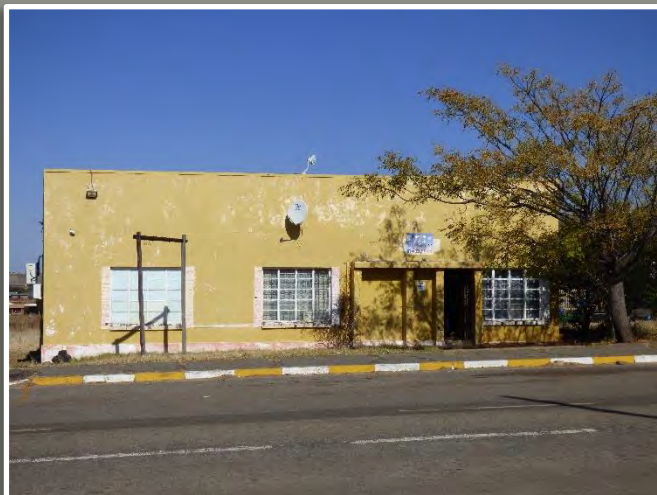
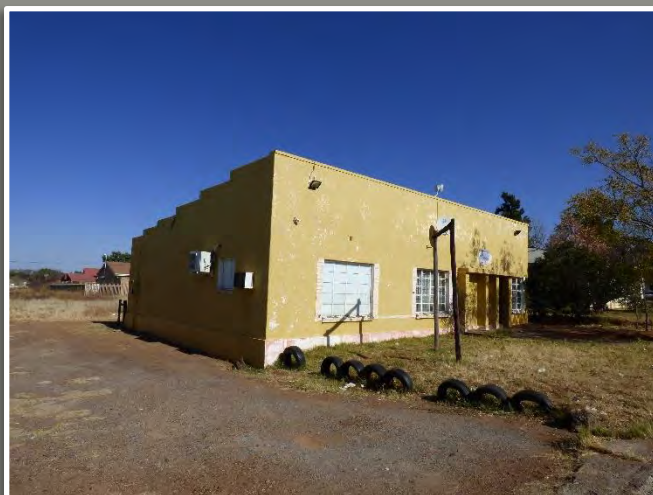
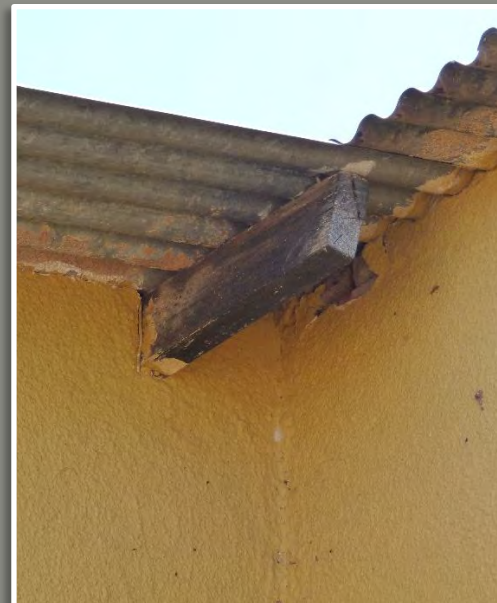
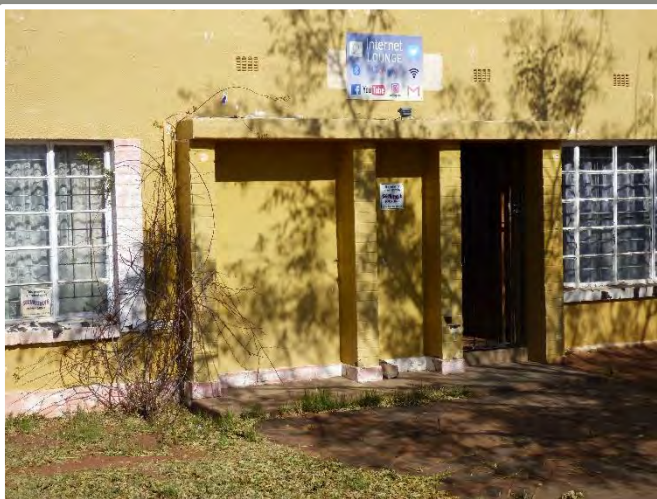
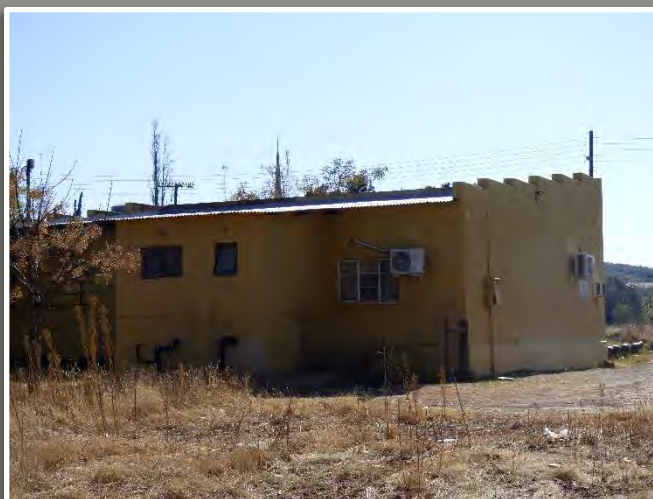
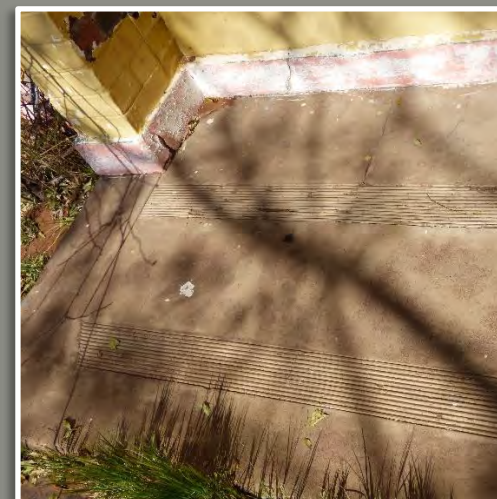
## 8. COMMERCIAL: *Hoof Street Internet Cafe*

| SITE DESCRIPTION | | | | | | |
|---|---|---|---|---|---|---|
| Condition | Structurally fair | | | | | |

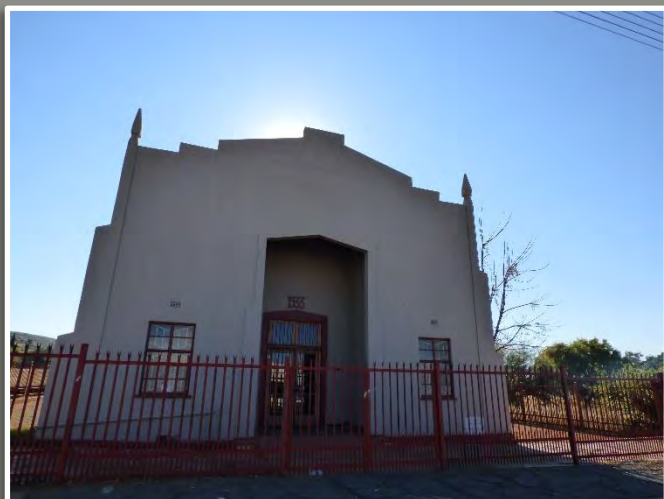
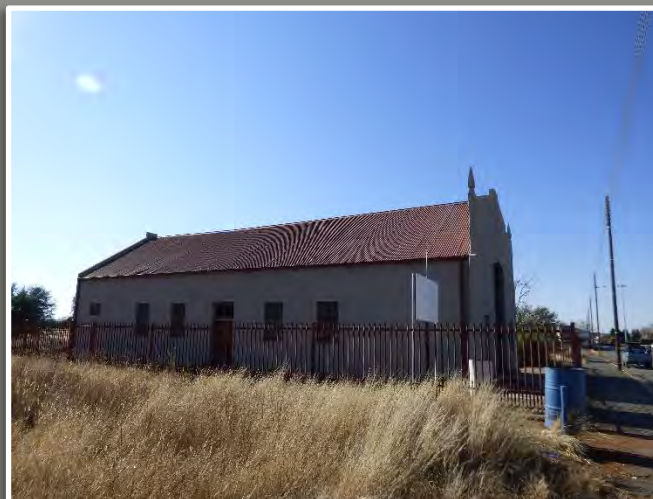
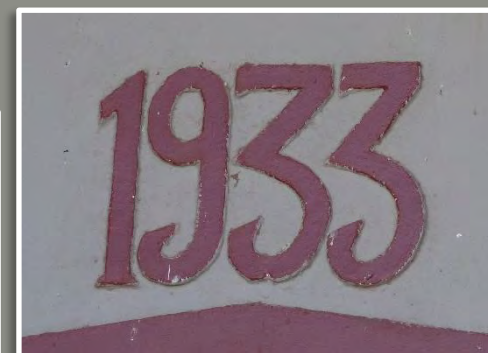
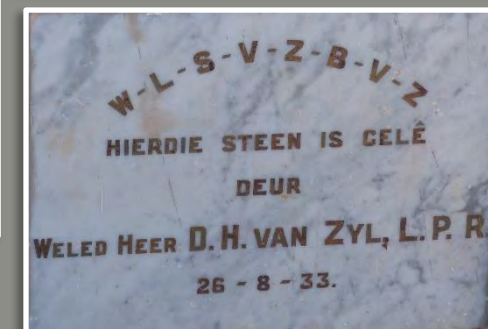
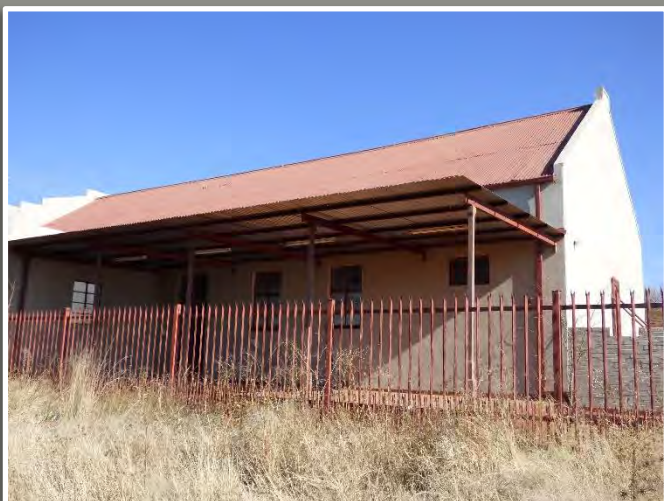
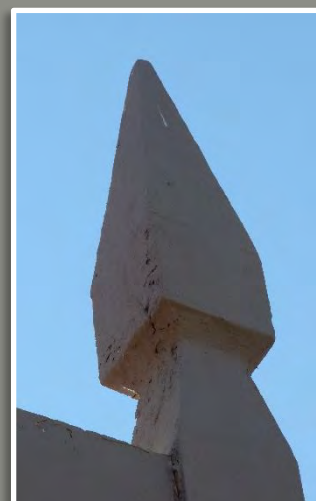
## 9. COMMUNITY: Town Hall

| SITE DESCRIPTION | | | | | | |
|---|---|---|---|---|---|---|
| Past Renovations, Alterations, Restorations | Painted, structural upgrading, palisade fencing and new extension on the eastern side | Identified Threats | Cracks, some loose roof plates | | | |

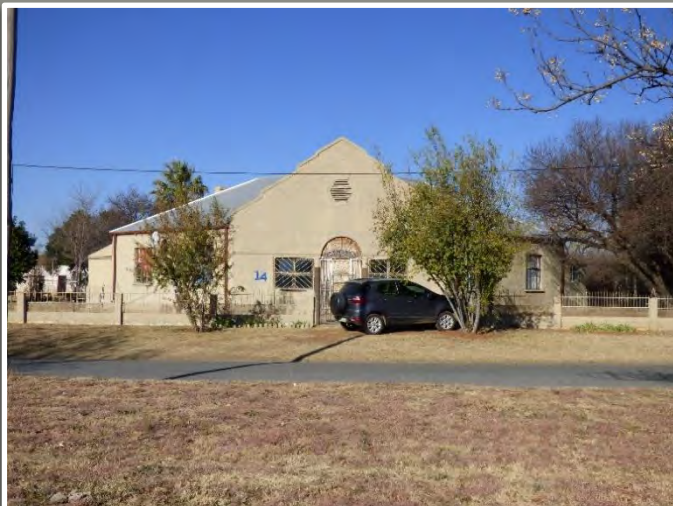
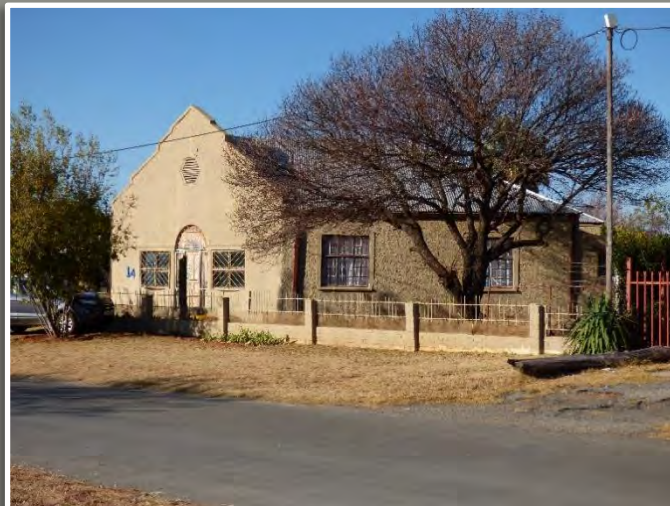
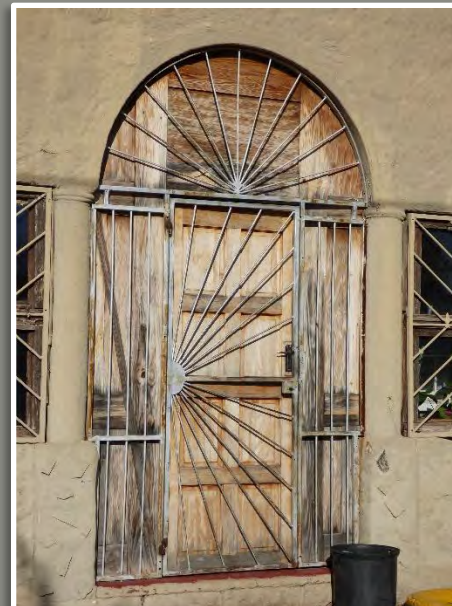
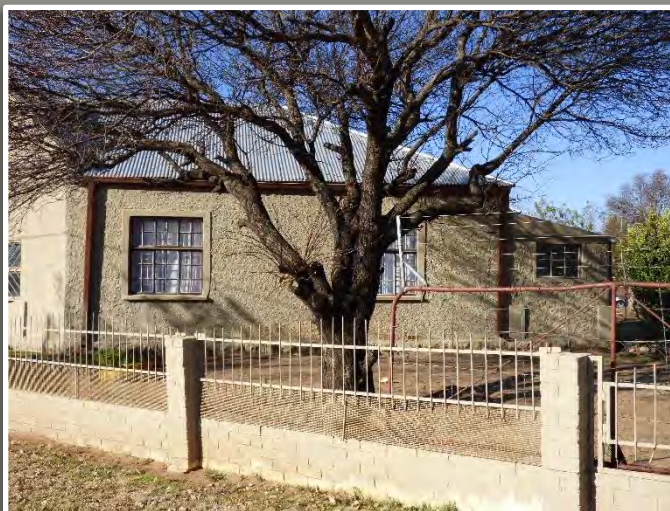
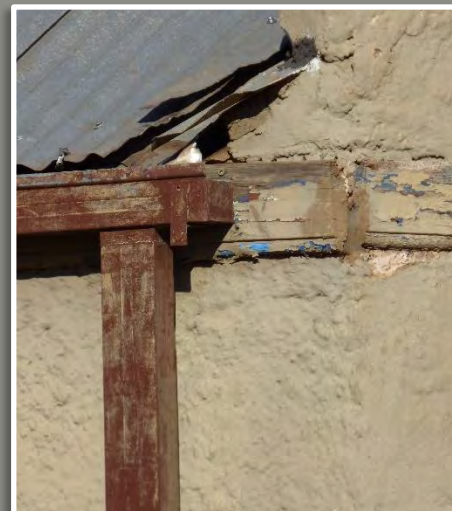
## 10. RESIDENTIAL: No.14 Skou Street

| SITE DESCRIPTION | | | | | | |
|---|---|---|---|---|---|---|
| Description of Architectural Features | The arched and pillared door faces north. There is a stepped gable at the front of the house with a hexagonal wood louvred vent. The house was not built on a rectangular or square plan, but juts out to the side and back. The pitched roof is covered in corrugated -iron, with the original wooden support beams still visible. There is a chimney towards the southeast. There is a variety of window shapes, as well as modern window replacements to the southeast. | | | | | |
| Condition | Fair, but some maintenance required. | | | | | |
| Past Renovations, Alterations, Restorations | There are modern additions to the back of the house, where a veranda was enclosed. | | Identified Threats | None | | |

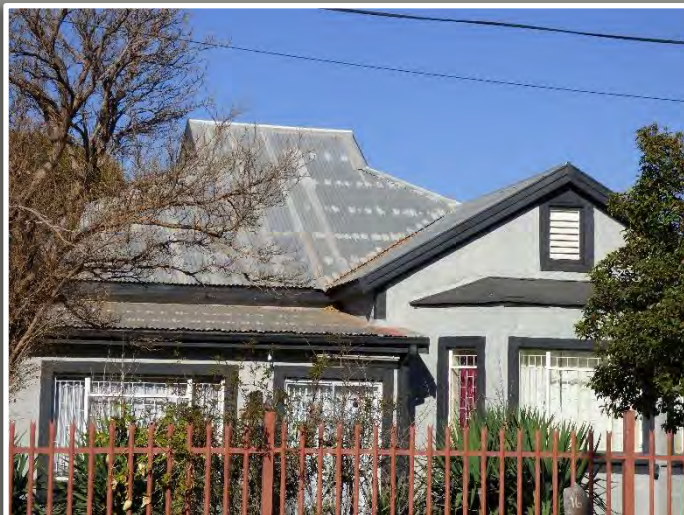
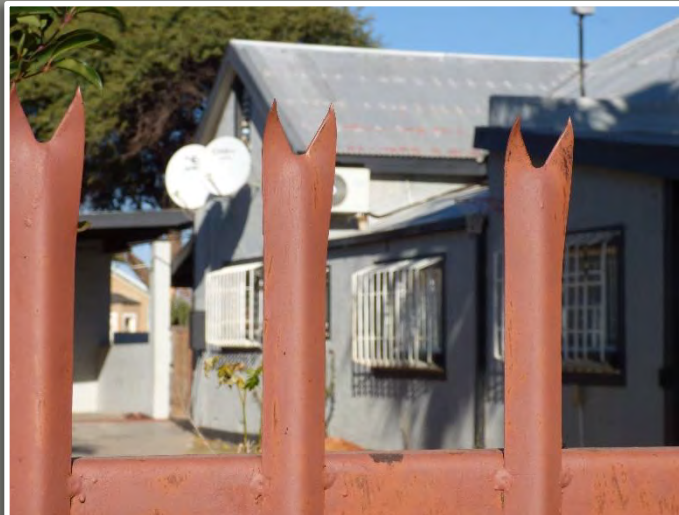
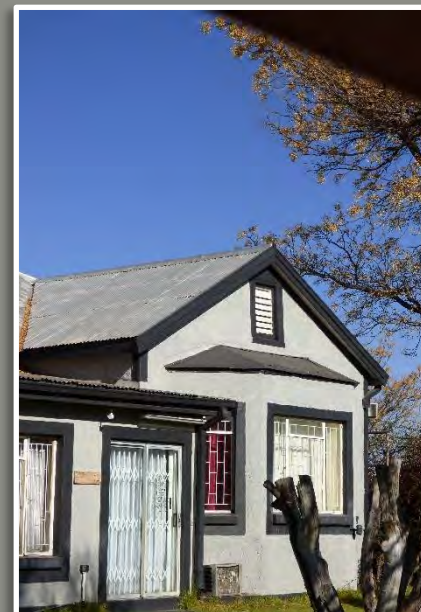
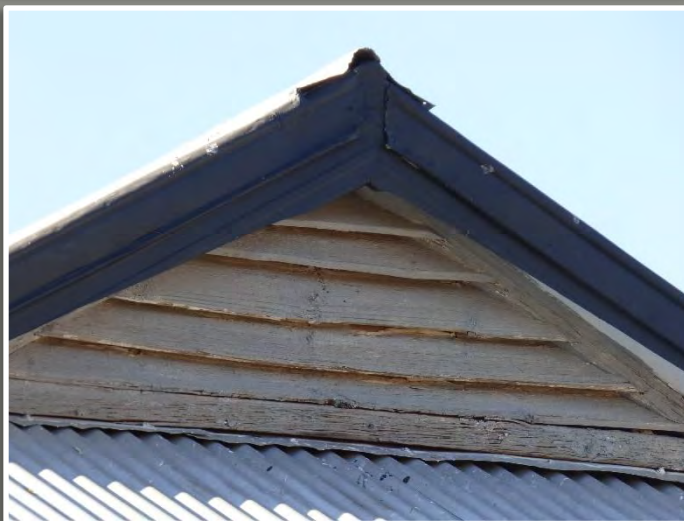
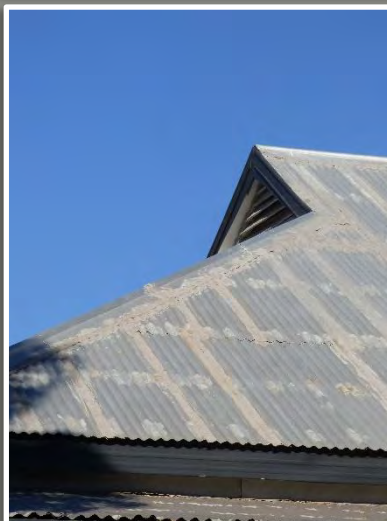
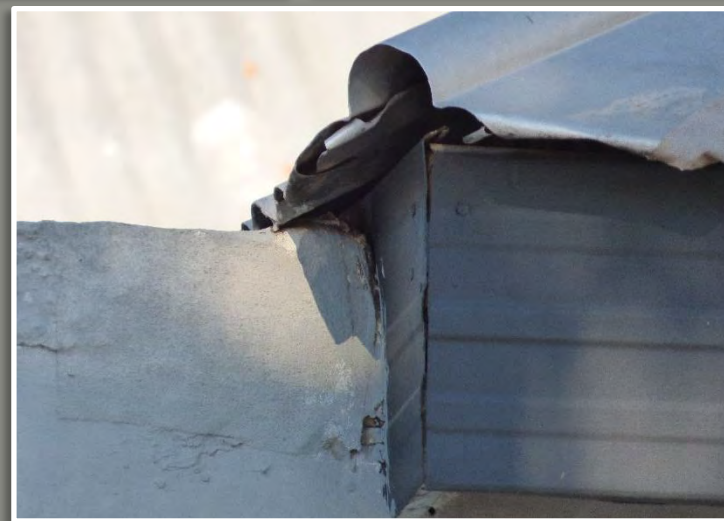
## 11. RESIDENTIAL: No.16 Skou Street

| SITE DESCRIPTION | | | | | | |
|---|---|---|---|---|---|---|
| Condition | Good | | | | | |
| Past Renovations, Alterations, Restorations | It has been well renovated, updated and modernised while keeping the unique features of the building. Windows have been fitted with burglar bars. Property surrounded with a palisade fence. | | Identified Threats | | None | |

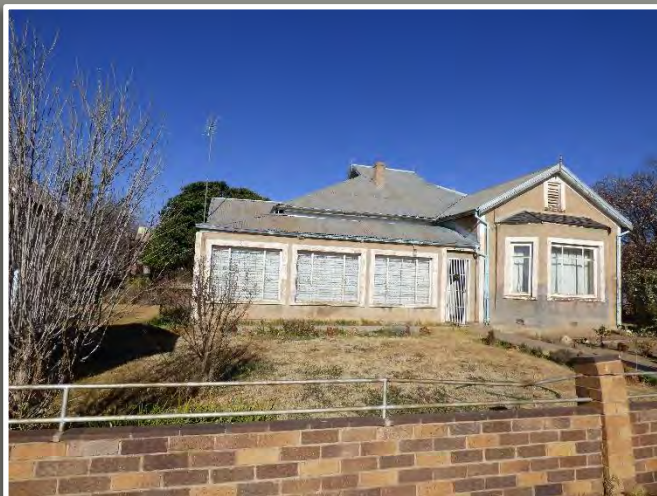
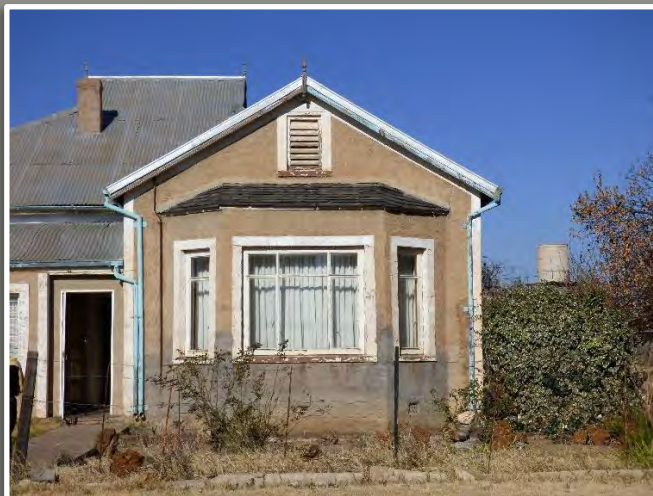
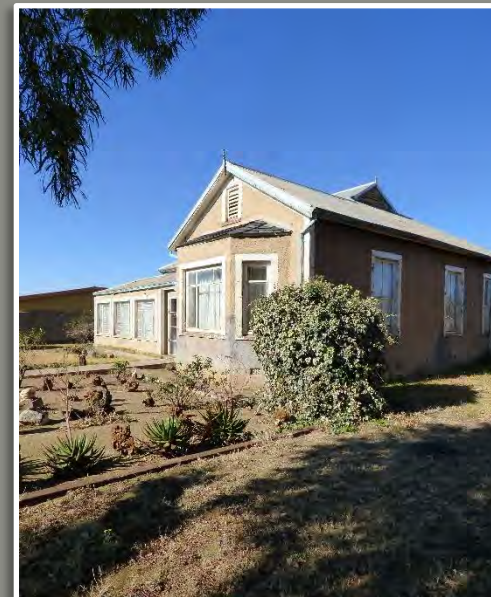
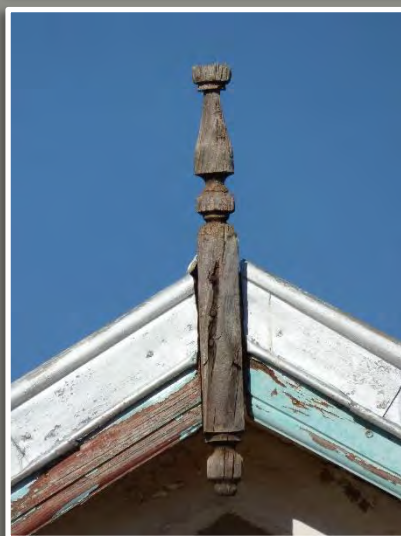
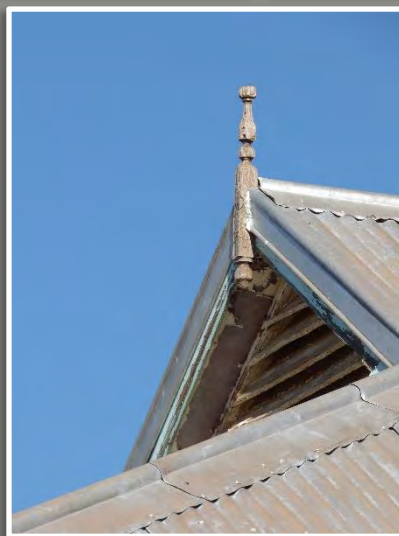
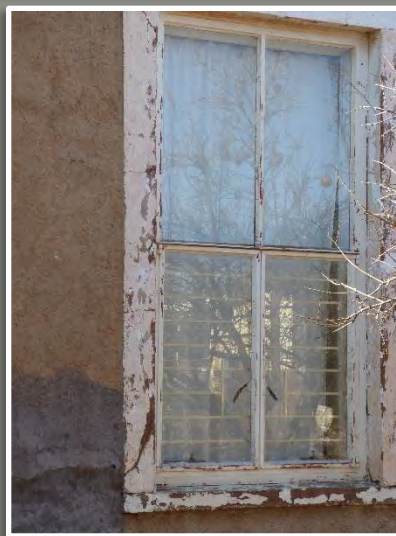
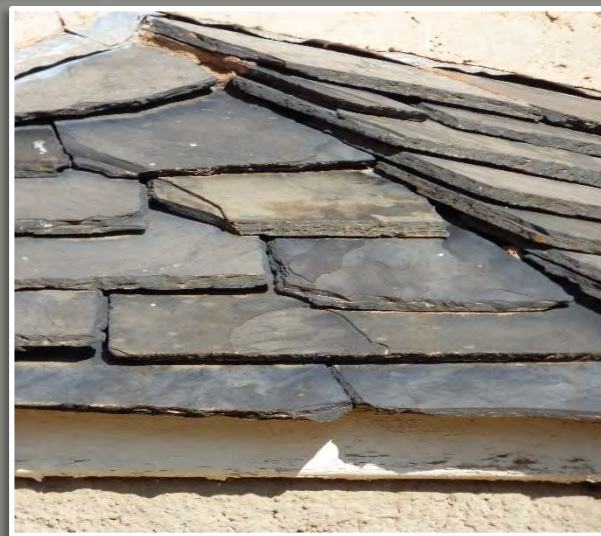
## 12. RESIDENTIAL: *The Smook House*

| SITE DESCRIPTION | | | | | | |
|---|---|---|---|---|---|---|
| Condition | Not good. In urgent need of restoration and maintenance, but exceptional historical architecture. | | | | | |
| Past Renovations, Alterations, Restorations | The veranda was closed off sometime in the middle of the 20 <sup>th</sup> century. | | Identified Threats | | Neglect, lack of maintenance. | |
