# *Danielskuil*

PHASE 1 HERITAGE INVENTORY AND ASSESSMENT  
OF THE TOWN DANIELSKUIL,  
KGATELOPELE LOCAL MUNICIPALITY,  
ZF MGCAWU DISTRICT MUNICIPALITY,  
NORTHERN CAPE.

SEPTEMBER 2021

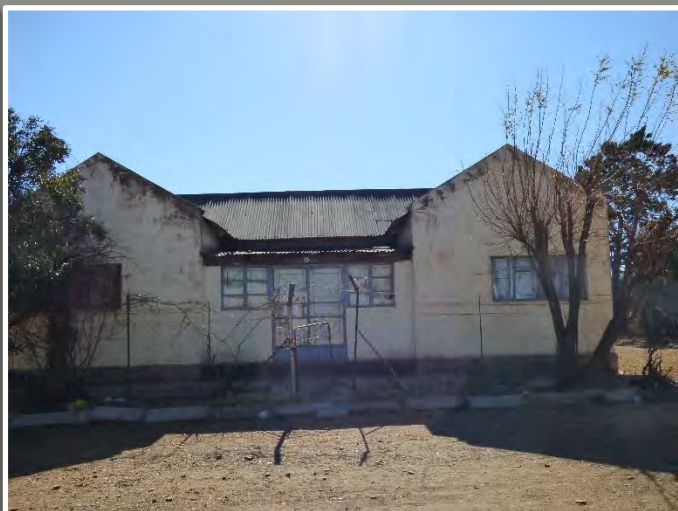
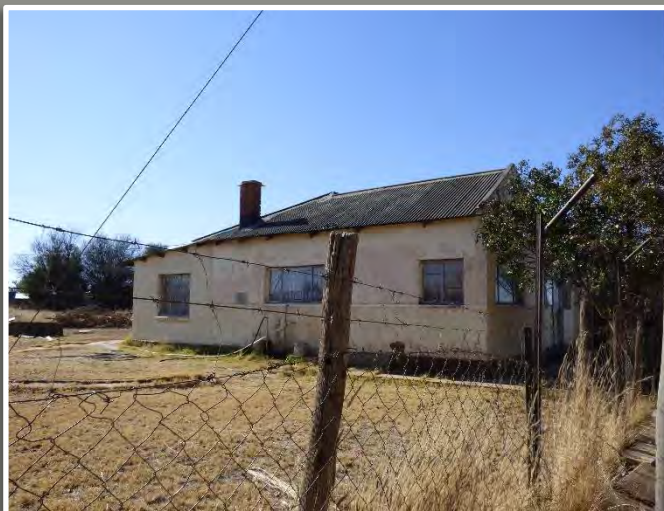
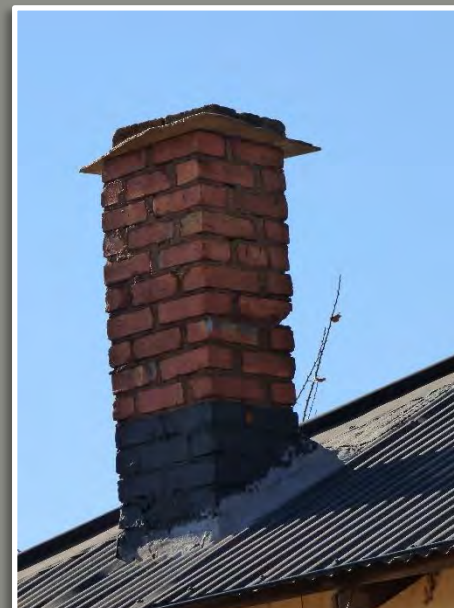
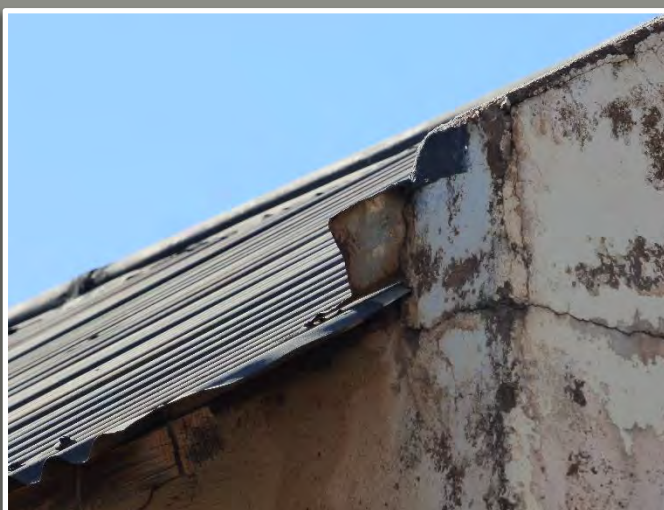
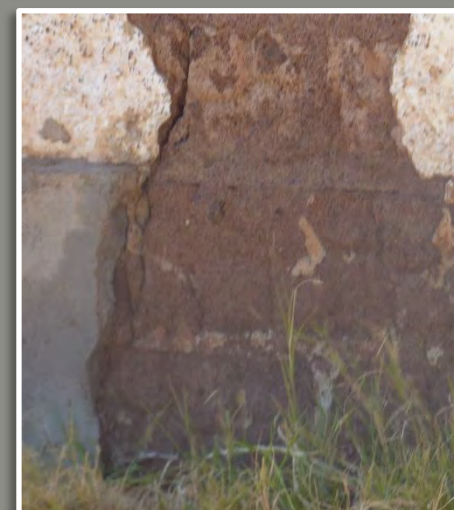
### 13. RESIDENTIAL: *Ruby Cottage*

| SITE DESCRIPTION | | | | | | |
|---|---|---|---|---|---|---|
| Description of Architectural Features | The structure is a U-shaped cottage with a dolomite stone foundation. The area between the forward-facing wings has been closed off with modern glass doors and windows. The corrugated iron pitched roof has a chimney on the side, which was added later. An addition has been made towards the south of the building, adding a modern touch. | | | | | |
| Condition | Poor. Urgent need for maintenance and renovations | | | | | |
| Past Renovations, Alterations, Restorations | The area between the wings might have been a veranda that had been closed up. Modernised extension towards the back. New chimney. | | Identified Threats | Neglect. | | |

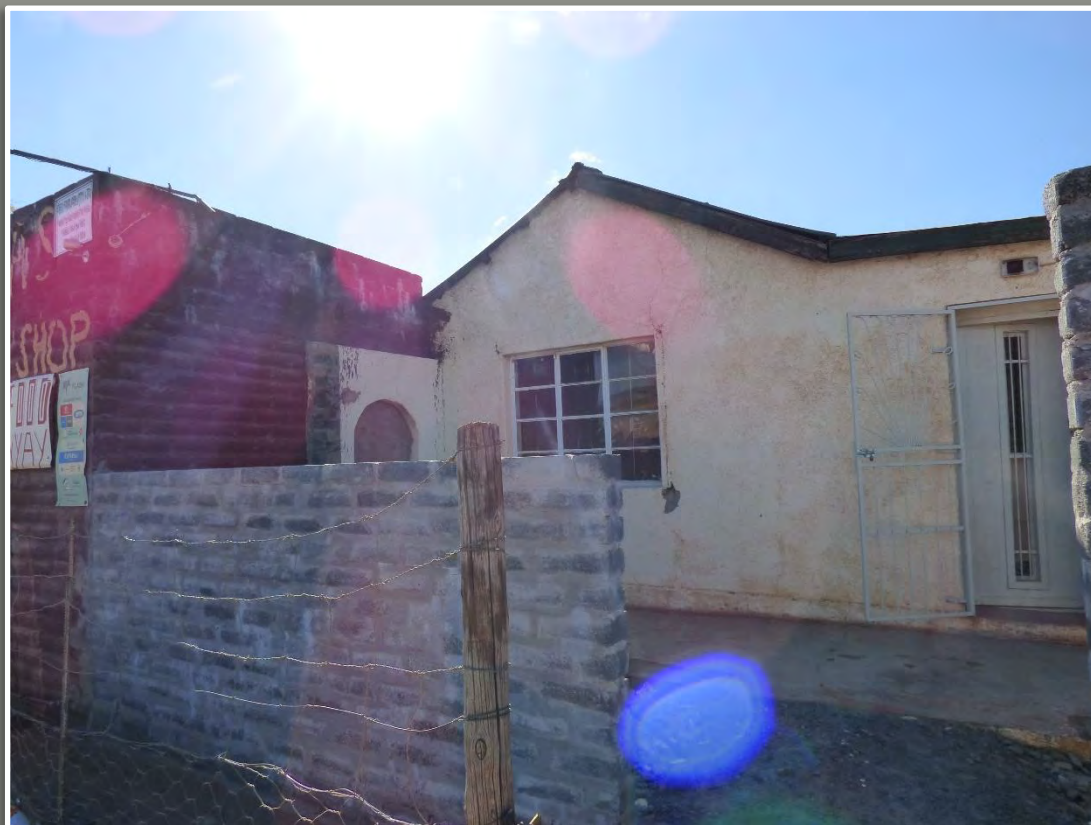
## 14. RESIDENTIAL: *Ruby Cottage 2*

| SITE DESCRIPTION | | | | | | |
|---|---|---|---|---|---|---|
| Description of Architectural Features | Twin pediment-gabled corrugated roof with original fascia boards, altered with a tuckshop to the west. Possibly stone foundation, lime plastered. Original metal window frames. The door is deep-set with a burglar safety gate. | | | | | |
| Condition | Poor. Urgent need for maintenance and renovations | | | | | |

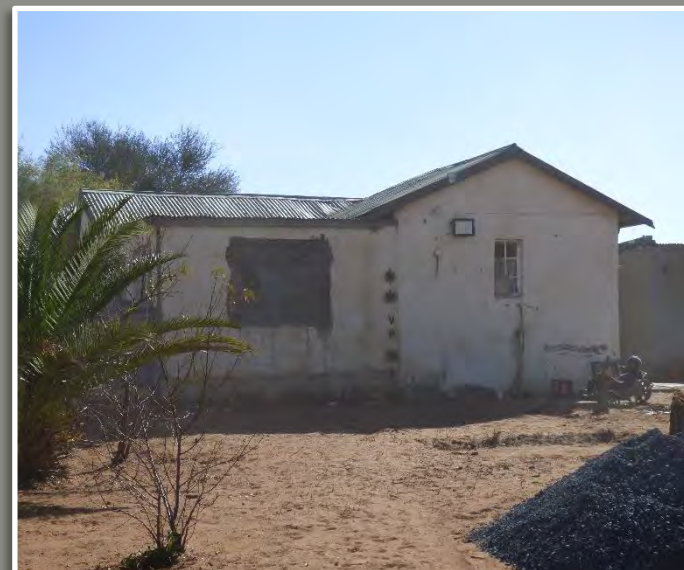
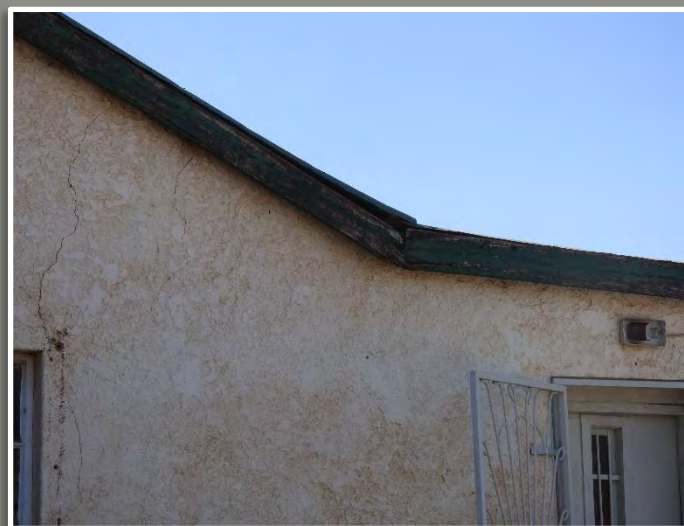
| SITE DESCRIPTION | | | | | | |
|---|---|---|---|---|---|---|
| Past Renovations, Alterations, Restorations | Plastering, painting and altered with tuck shop adjacent to the west. Closed up windows to the east. | | Identified Threats | | Neglect and what appears to be structural instability. | |

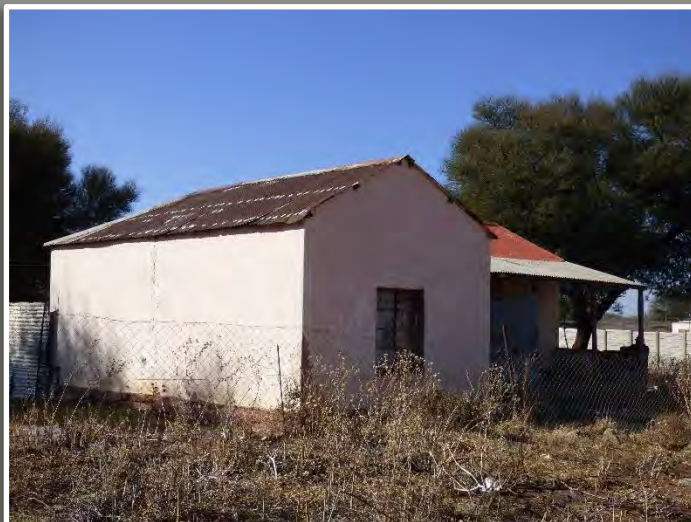
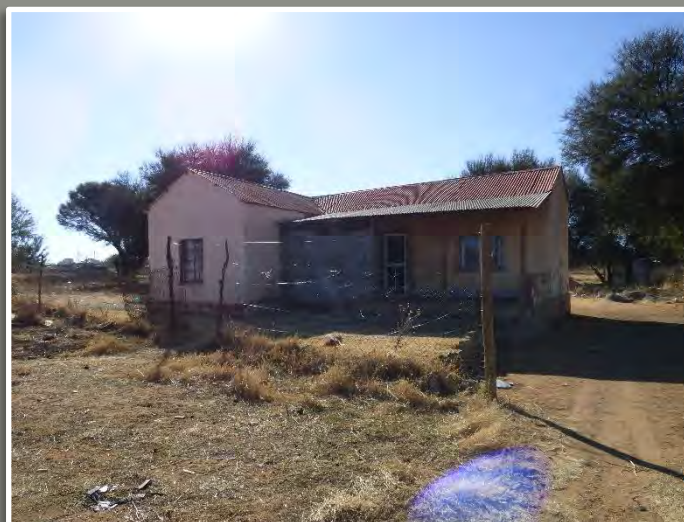
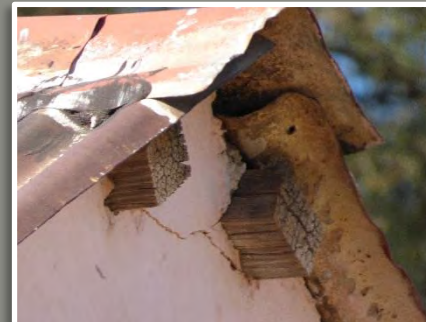
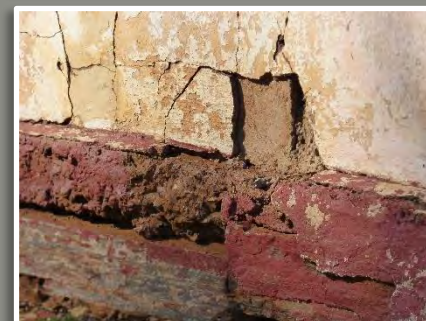
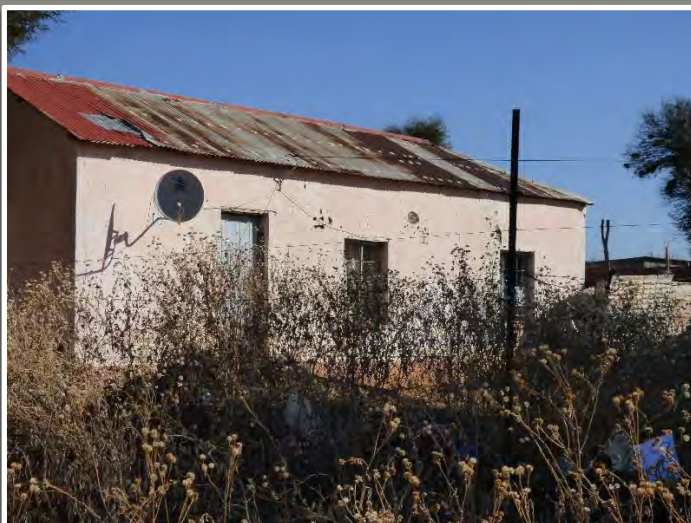
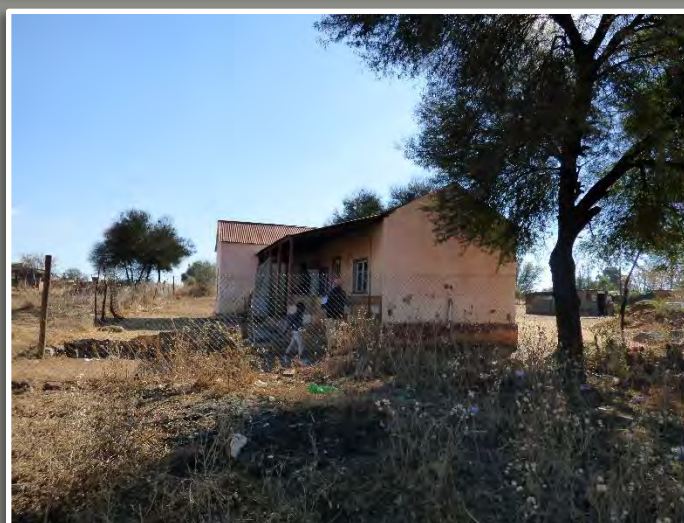
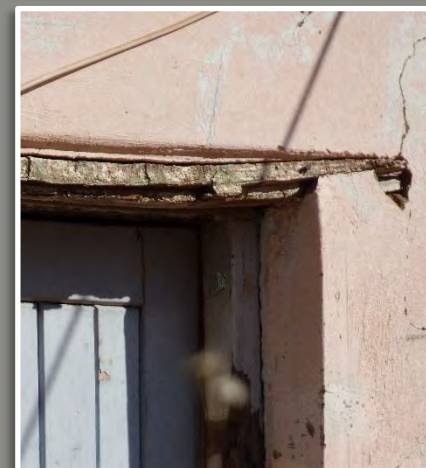
## 15. RESIDENTIAL: Scanlen Cottage

| SITE DESCRIPTION | | | | | | |
|---|---|---|---|---|---|---|
| Description of Architectural Features | Small Victorian cottage with veranda and entrance towards the south. Original wooden veranda pillars. Corrugated iron twin-apex steep roof. Entrance at the back, north. Stone foundation. | | | | | |
| Condition | Poor | | | | | |
| Past Renovations, Alterations, Restorations | Windows altered, veranda wall modernised towards the East—tiles on the veranda and plastered sections on walls. | | Identified Threats | Neglect. Structural damage in certain areas. Plaster coming off at the veranda, and the roof is in poor repair. | | |

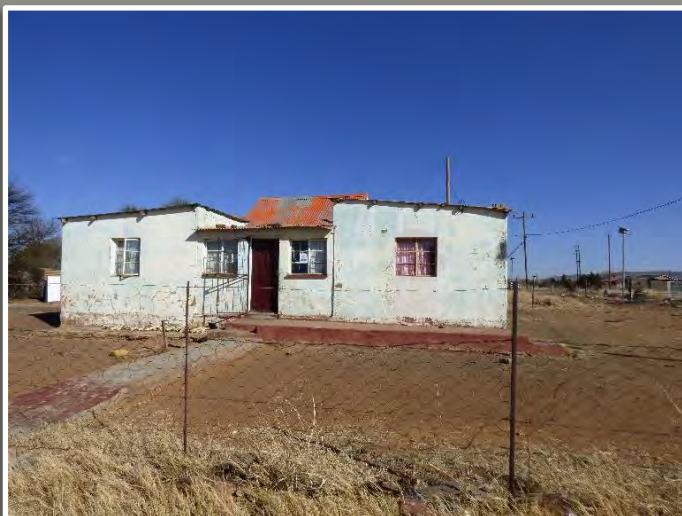
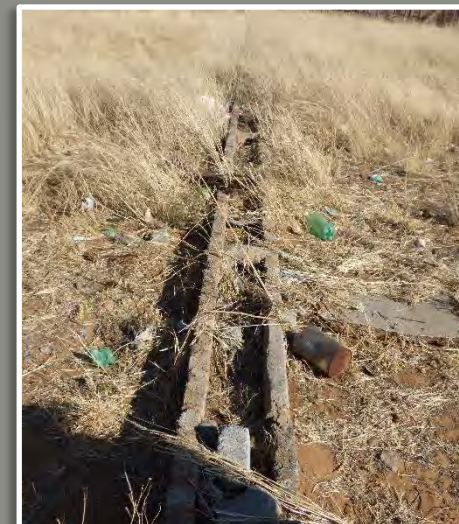
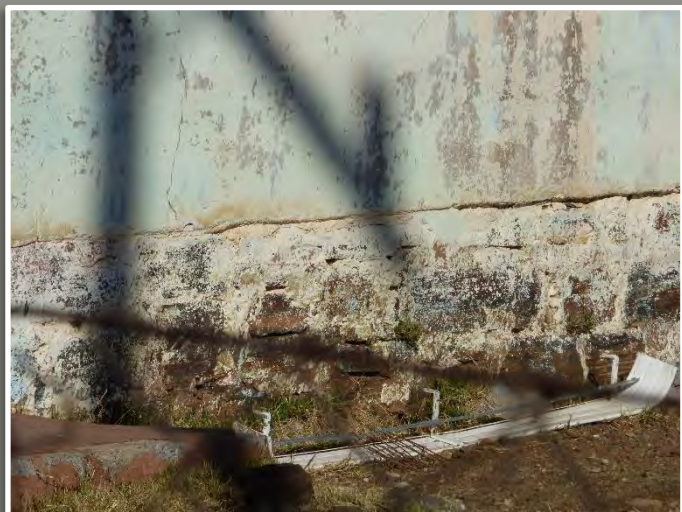
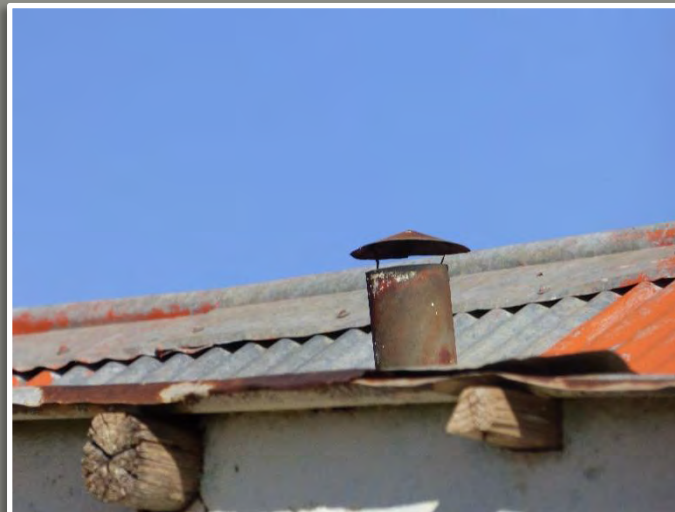
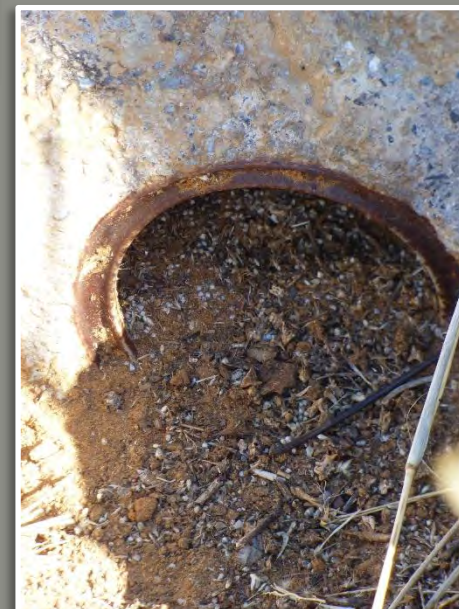
## 16. RESIDENTIAL: Mackenzie Cottage

| SITE DESCRIPTION | | | | | | |
|---|---|---|---|---|---|---|
| Description of Architectural Features | Entrance towards the north. Corrugated single apex roof, small cottage with two added sections west and East of roof apex. Flat roofed rooms. Stone foundation. Windows seem original. New modernised addition to the south of the house. Water furrow that has been lined with old thick tins in the back yard. | | | | | |
| Condition | Poor | | | | | |

| SITE DESCRIPTION | | | | | | |
|---|---|---|---|---|---|---|
| Past Renovations, Alterations, Restorations | The corrugated roof has been replaced in certain areas. Also, plastering has been done on particular walls, secured entrance. | | Identified Threats | The roof is collapsing, and there could be a possible structural failure. | | |

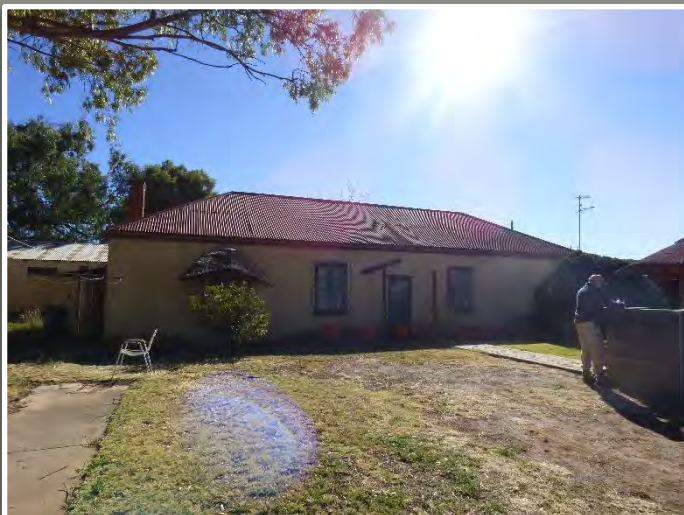
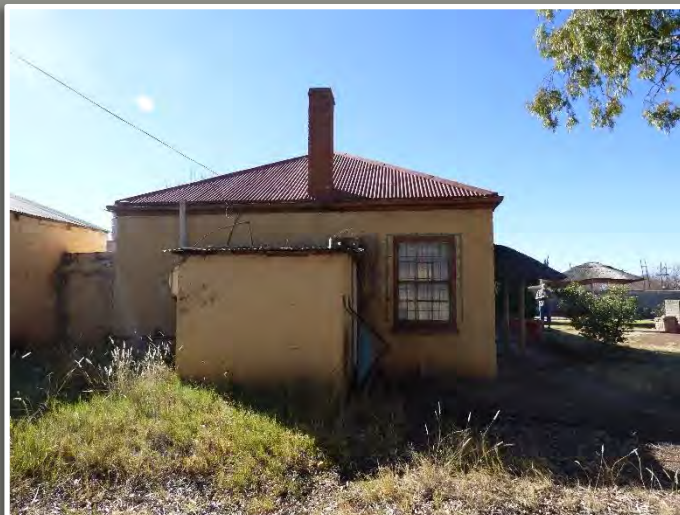
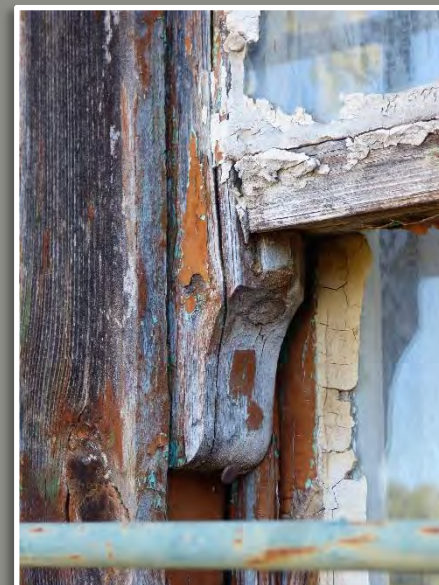
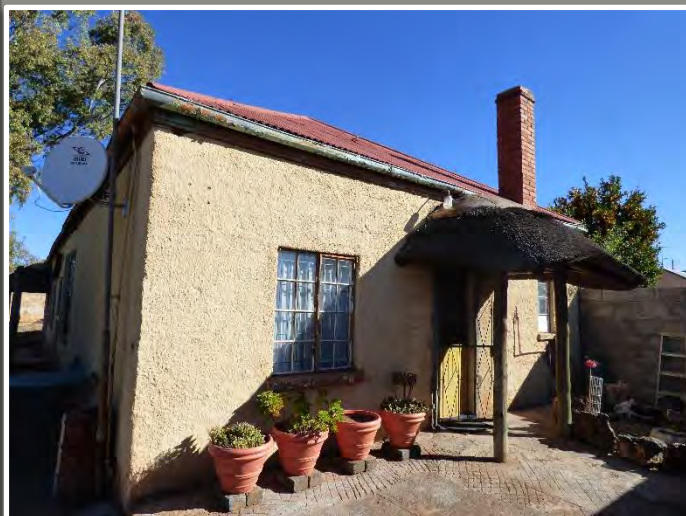
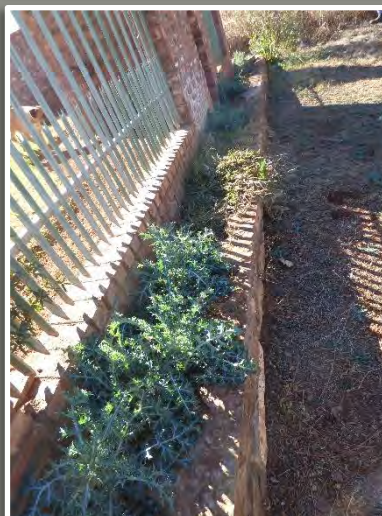
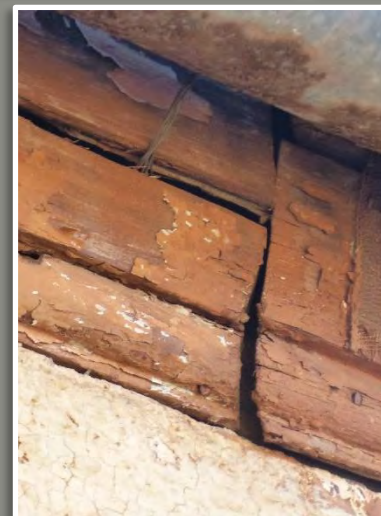
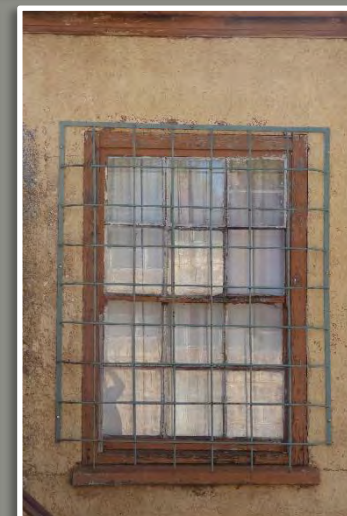
## 17. RESIDENTIAL: *Old Hostel Kitchen House*

| SITE DESCRIPTION | | | | | | |
|---|---|---|---|---|---|---|
| Condition | Poor | | | | | |
| Past Renovations, Alterations, Restorations | Burglar bars and security, gates and entrances. Thatch roofing over the eastern doorway. | | Identified Threats | | Lack of maintenance. | |

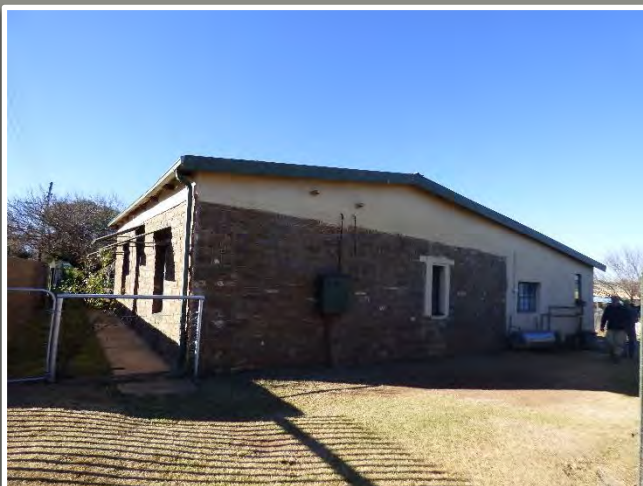
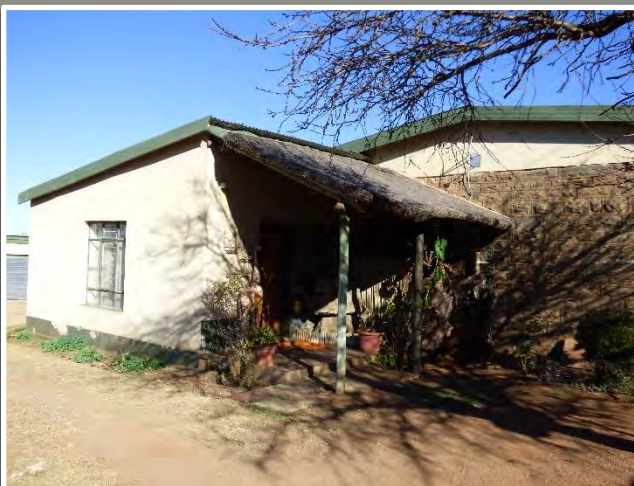
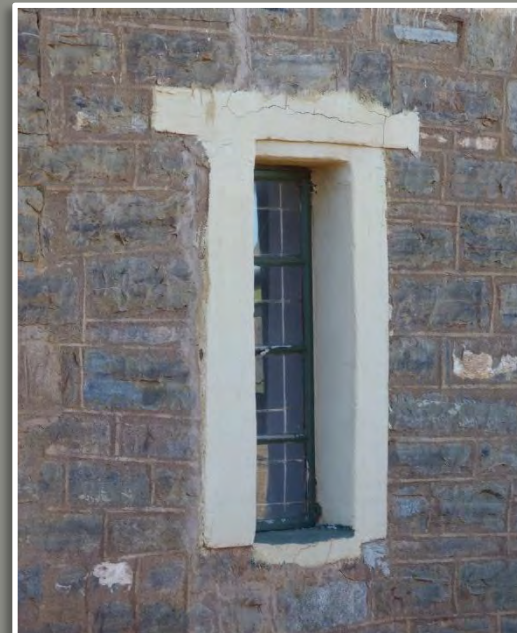
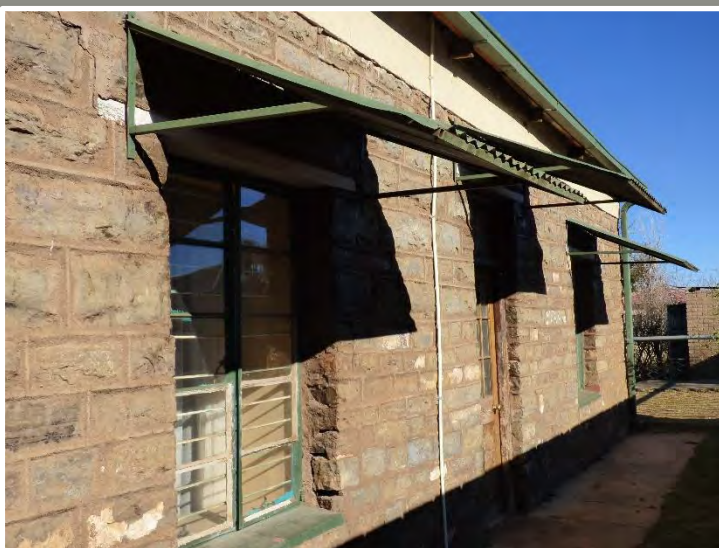
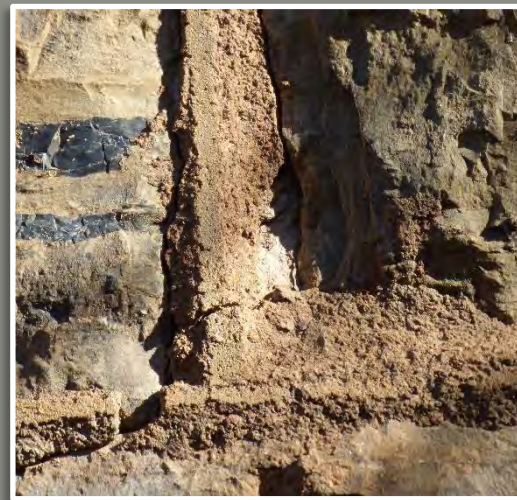
## 19. RESIDENTIAL: *Barkhuysen House*

| SITE DESCRIPTION | | | | | | |
|---|---|---|---|---|---|---|
| Description of Architectural Features | Entrances towards west and east. The corrugated roof is pitched with a shallow slant towards the east. The house was built with dolomite stones and dolomite foundations. Wall thickness is approximately 60 cm. There is red ground mortar between the stones and finished off with cement. Original windows, roof beams, lintels and door frames. | | | | | |
| Condition | Fair | | | | | |

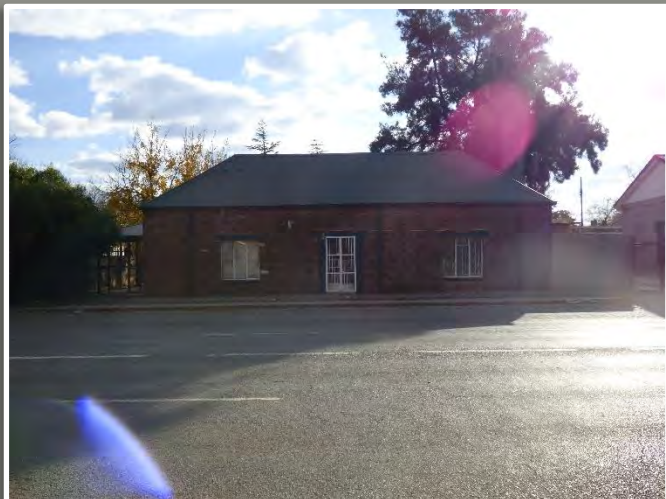
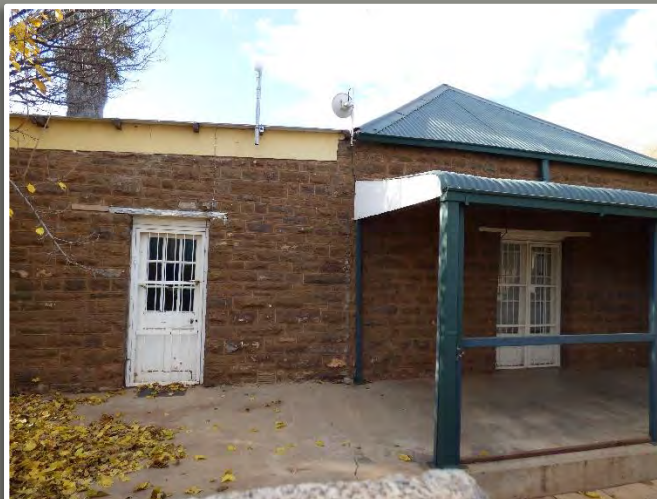
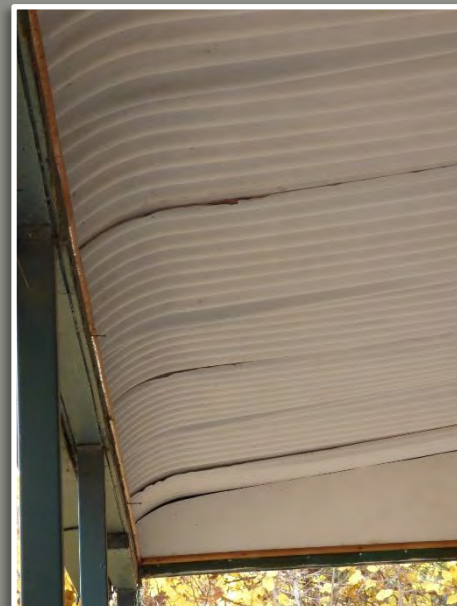
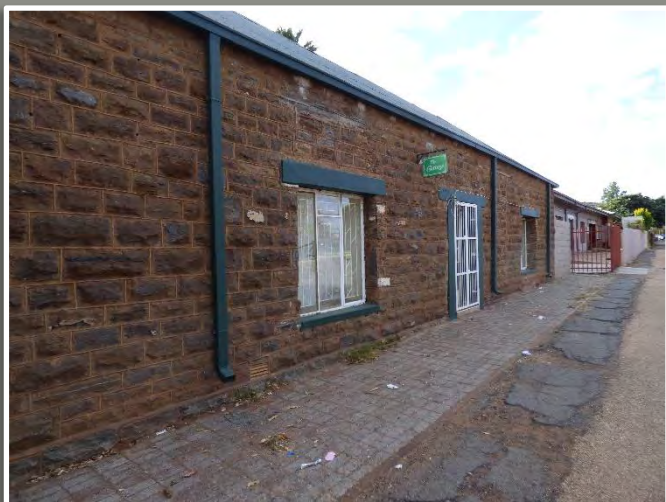
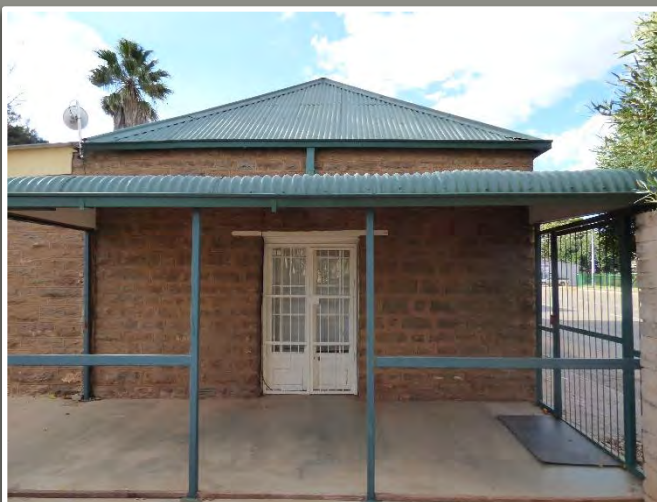
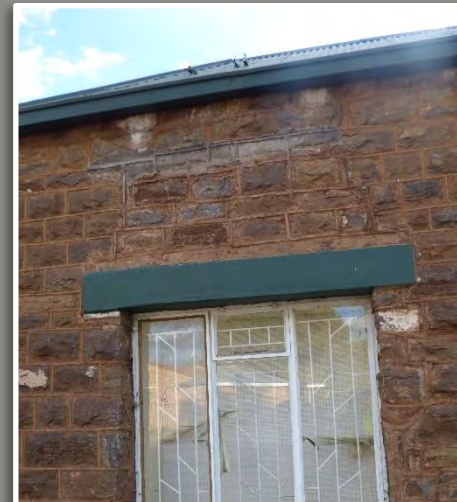
## 20. OLD POST OFFICE: Cottage

| SITE DESCRIPTION | | | | | | |
|---|---|---|---|---|---|---|
| Condition | Structurally fair | | | | | |

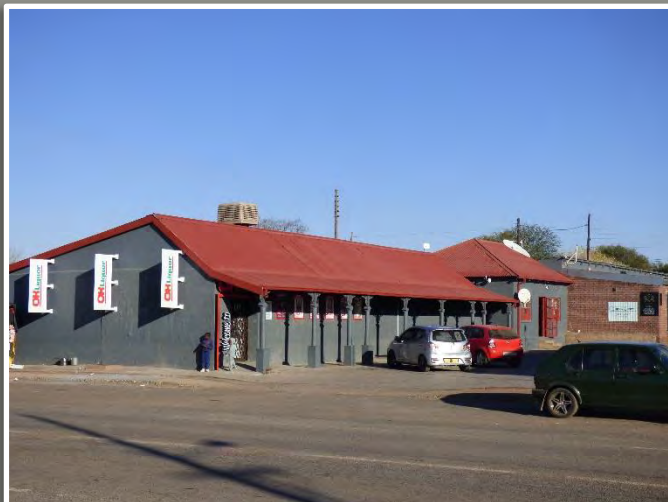
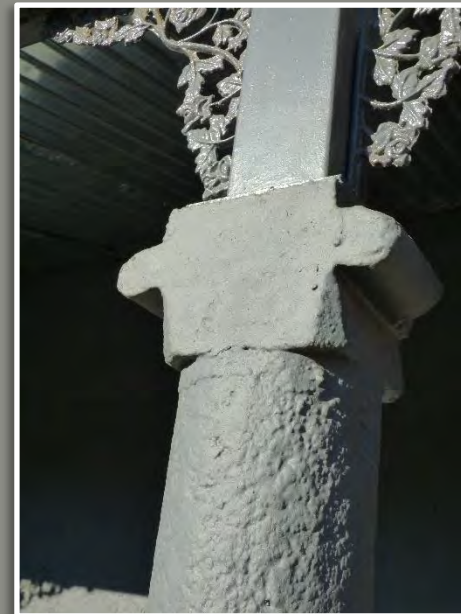
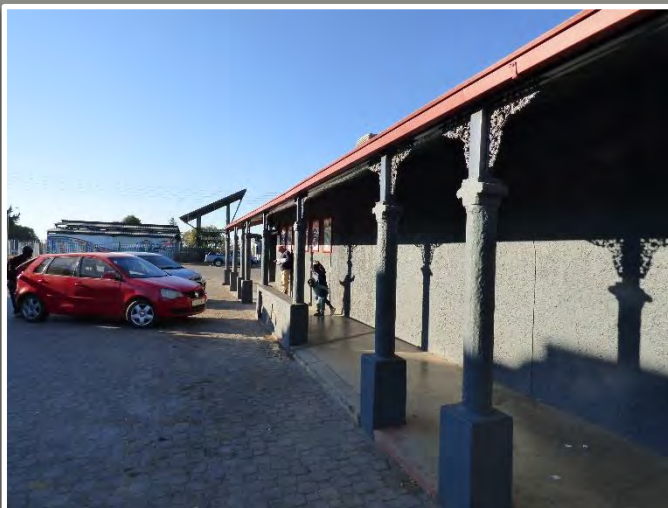
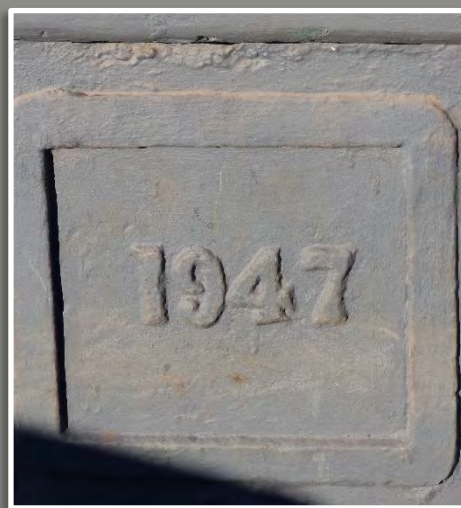
## 21. COMMERCIAL: OK Liquor

| SITE DESCRIPTION | | | | | | |
|---|---|---|---|---|---|---|
| Condition | Well maintained and restored | | | | | |
| Past Renovations, Alterations, Restorations | The whole building has been repainted and branded. The entrances have been altered. They added a garage door to the southern wall | Identified Threats | Maintenance. | | | |

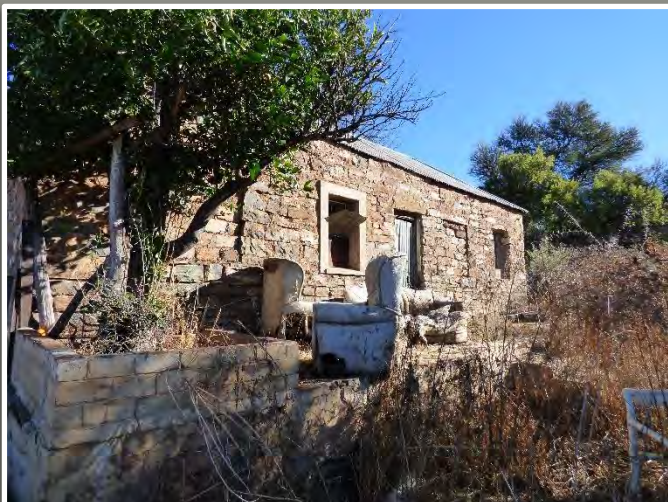
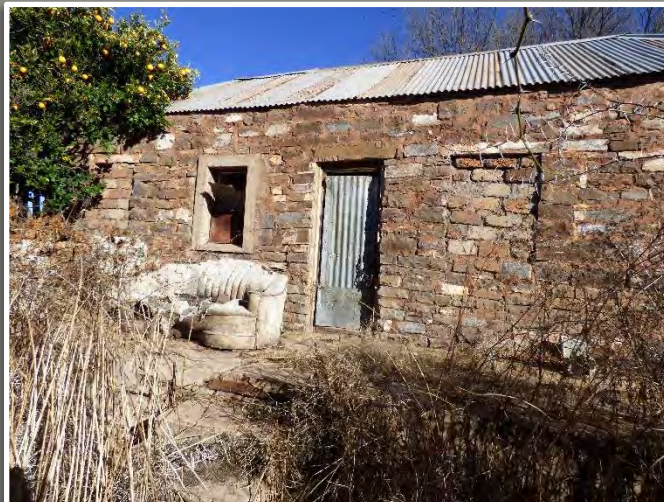
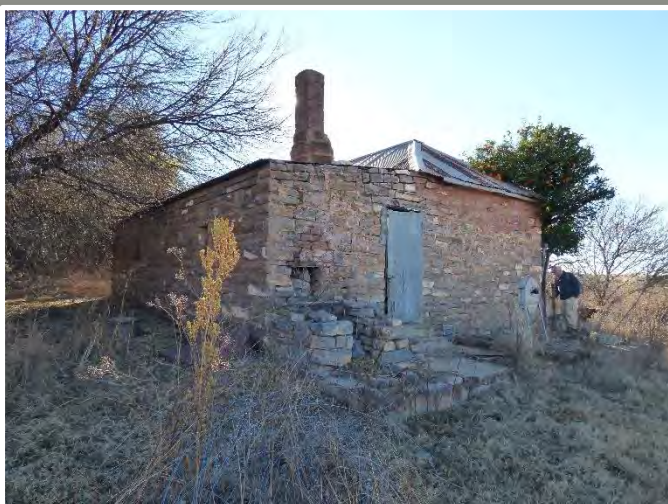
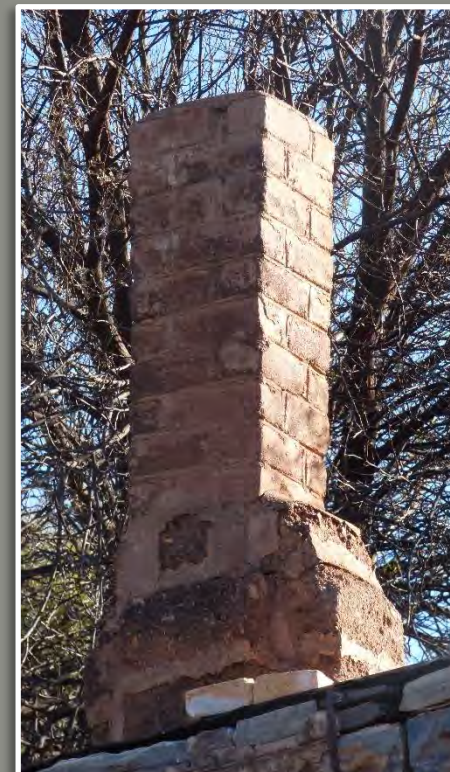
## 22. RESIDENTIAL: *Boplaas Cottage*

| SITE DESCRIPTION | | | | | | |
|---|---|---|---|---|---|---|
| Description of Architectural Features | A little rectangular dolomite stone structure with a north-facing entrance and a pitched corrugated iron roof with flat-roofed addition to the south. Original windows frames have been replaced by iron frames. Original roof beams and lintels. Elevated stoep in front of the entrance. Chimney in the southeast corner of the roof with old geyser ("donkey") attached to house/kitchen. | | | | | |
| Condition | Poor | | | | | |
| Past Renovations, Alterations, Restorations | Window replacements, door replaced, veranda altered, minor renovations possible | | Identified Threats | | Dilapidated roof and structure. Unsafe. Rotten wooden beams, overgrown vegetation, fire risk. | |

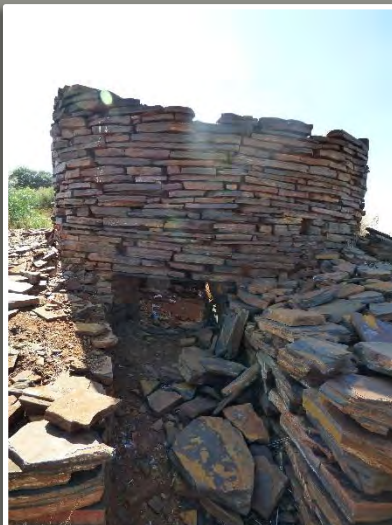
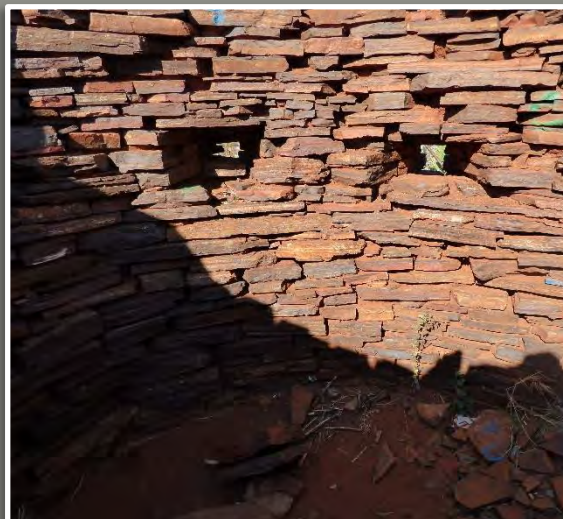
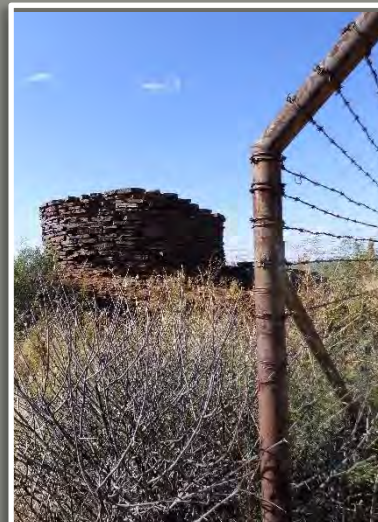
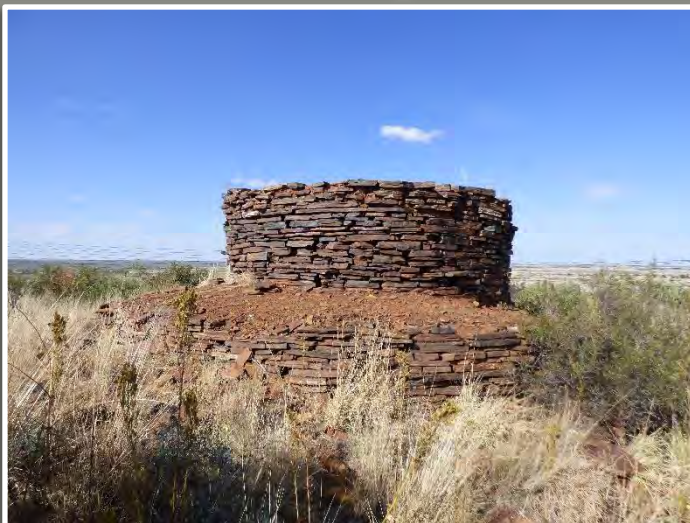
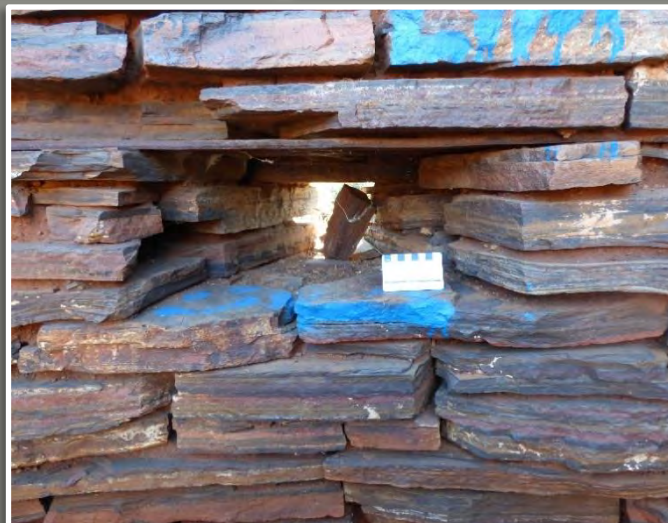
### 23. MILITARY: Anglo-Boer War British Fort

| SITE DESCRIPTION | | | | | | |
|---|---|---|---|---|---|---|
| Condition | Fair. 80% of walling is intact. There is no corrugation iron roofing left. Blue and green spray paint graffiti on inside walls and rubbish and refuse inside. | | | | | |
| Past Renovations, Alterations, Restorations | None. Fenced-off around fort structure, barbed wire (approx. 20 yards) | | Identified Threats | | Neglect and natural forces, such as wind erosion and no gate, as well as vandalism. | |

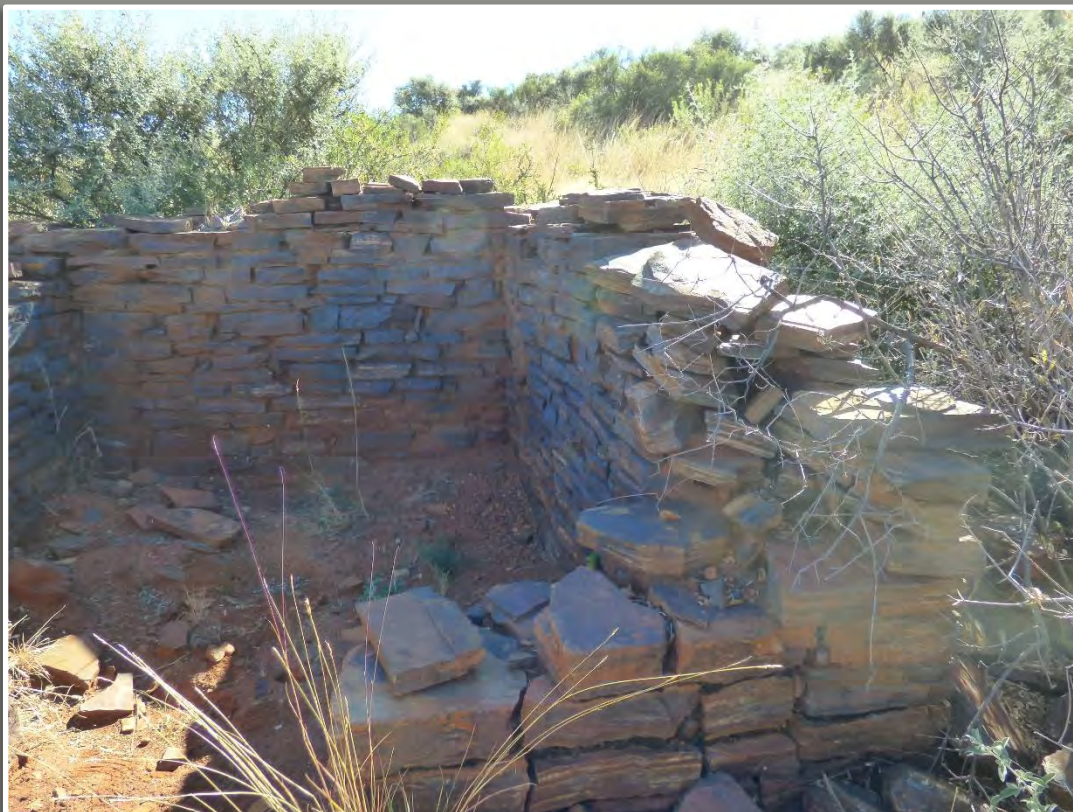
## 24. MILITARY: Anglo-Boer War British Structure

| SITE DESCRIPTION | | | | | | |
|---|---|---|---|---|---|---|
| Condition | Poor but effectively visible and identifiable. | | | | | |

| SITE DESCRIPTION | | | | | | |
|---|---|---|---|---|---|---|
| Past Renovations, Alterations, Restorations | None. | | Identified Threats | | Neglect and natural and human activities. | |

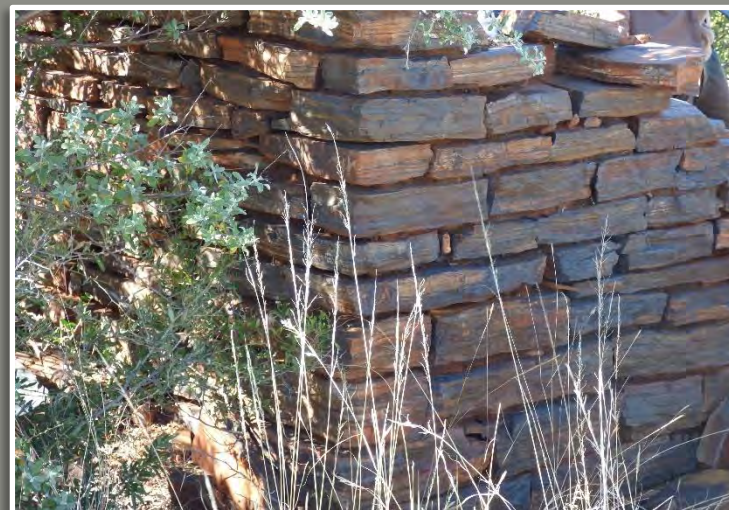
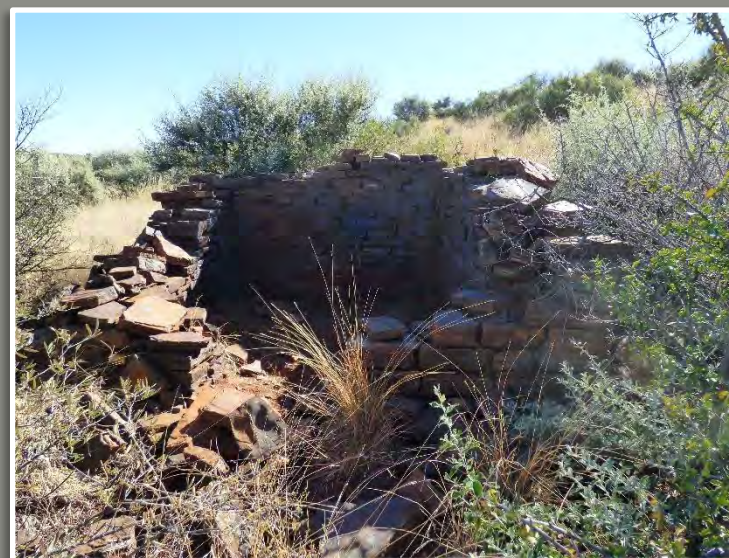
| SITE DESCRIPTION | | | | | | |
|---|---|---|---|---|---|---|
| Description of Architectural Features | The remains of a square structure built of shale stones, (3x3 m <sup>2</sup> ) found in the proximity of the British fort. It seems like the entrance was towards the southeast—approximately 1.5 m high walls. Unfortunately, the structure is abandoned, and some walls have collapsed. There are traces of red ground mortar between stones, especially to the southern end. | | | | | |

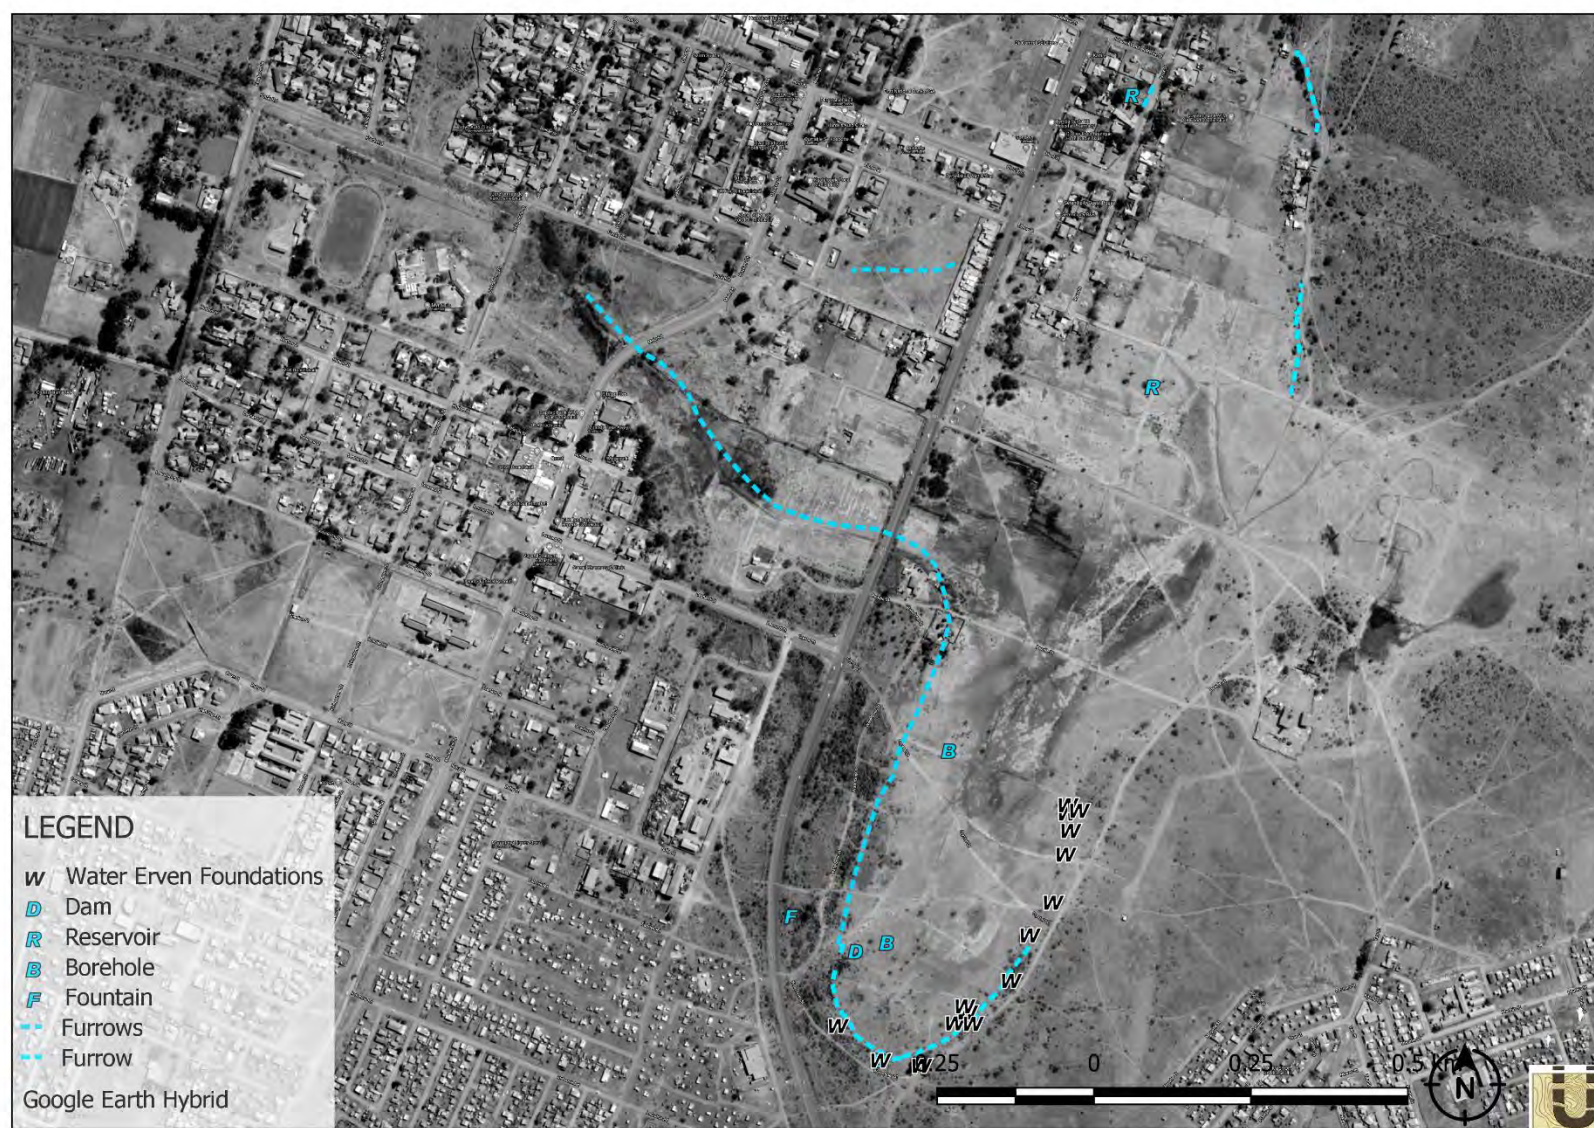
Figure 14 The water furrows and water storage, as part of irrigation scheme. Image: UBIQUE Heritage Consultants

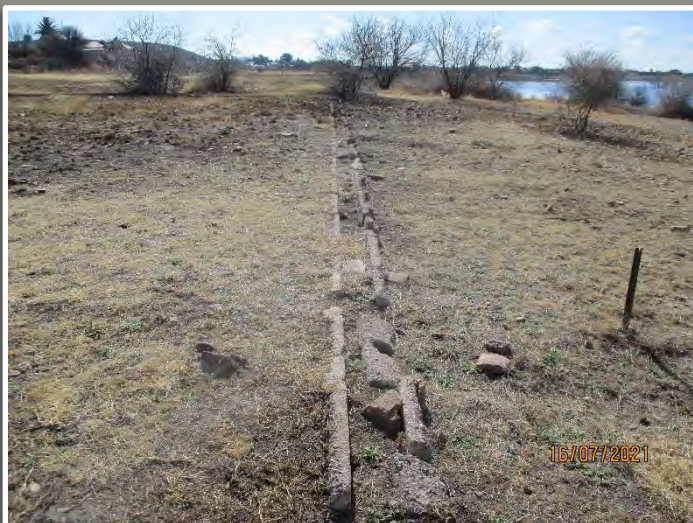
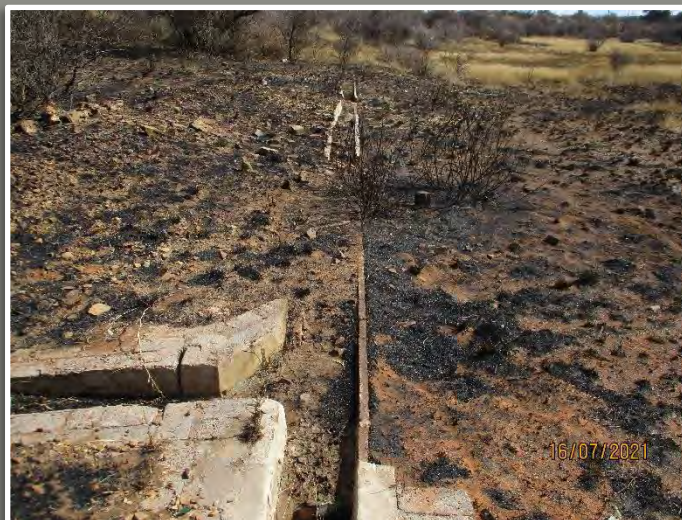
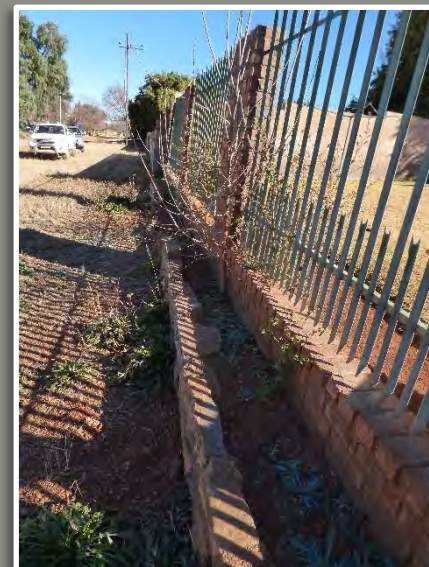
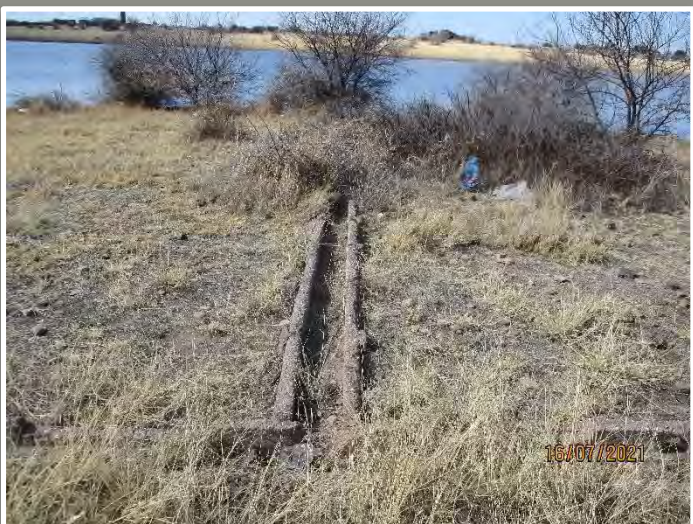
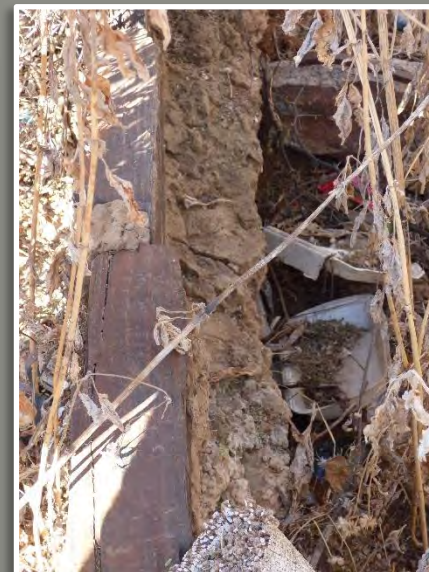
## IRRIGATION: Water Furrows

| SITE DESCRIPTION | | | | | | |
|---|---|---|---|---|---|---|
| Condition | Poor to Fair | | | | | |
| Past Renovations, Alterations, Restorations | Upgrades and alterations and past repairs. | | Identified Threats | | Neglect. All the waterwork and irrigation related heritage resources need to be mapped in their entirety. | |
