# *Danielskuil*

PHASE 1 HERITAGE INVENTORY AND ASSESSMENT  
OF THE TOWN DANIELSKUIL,  
KGATELOPELE LOCAL MUNICIPALITY,  
ZF MGCAWU DISTRICT MUNICIPALITY,  
NORTHERN CAPE.

SEPTEMBER 2021

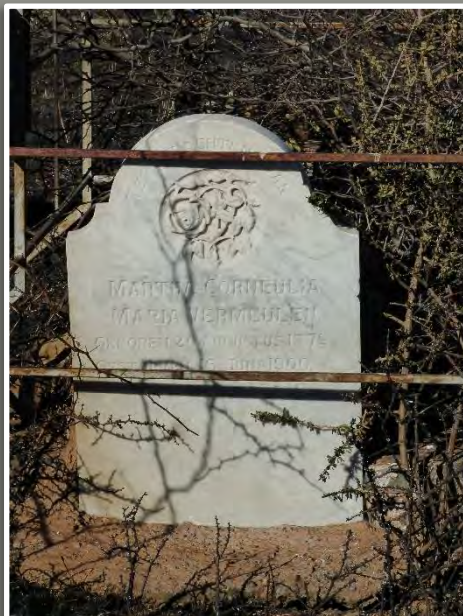
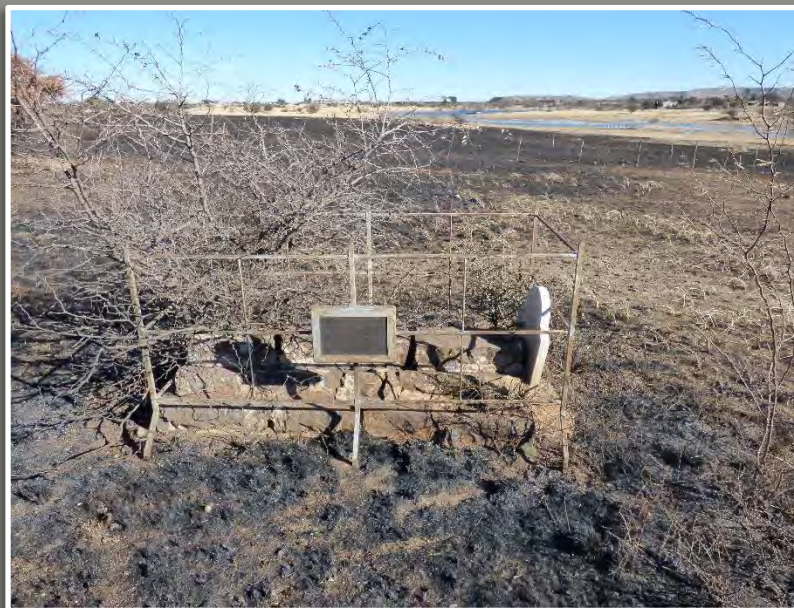
## GRAVEYARD: Martha Vermeulen's Grave

On 16 June 1900, a Boer girl, Martha Vermeulen, was shot dead by British soldiers, exacerbating the Boers' resentment toward the British. It is said that British soldiers thought armed rebels were hiding in the Vermeulens' home and had opened fire; the mother and son fled unharmed, but the young girl was killed (Snyman 1988).
